## **SECTION 2.2: FACILITIES ASSESSMENT REPORT**

**ASSESSMENT COMPLETED: NOVEMBER 2009**

## EXECUTIVE SUMMARY: UMATILLA CHEMICAL DEPOT

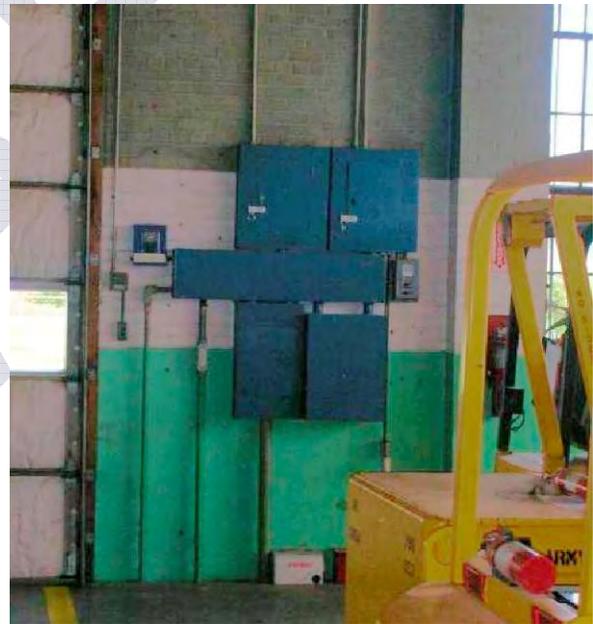
**Old Main Breaker and Distribution Panel Eastside**

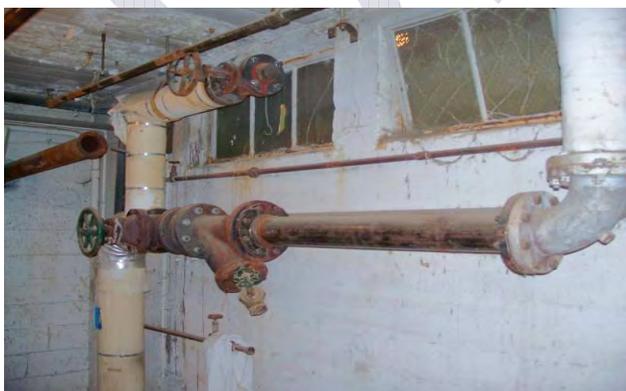
**Piping Code Violation- Building 11 Basement**

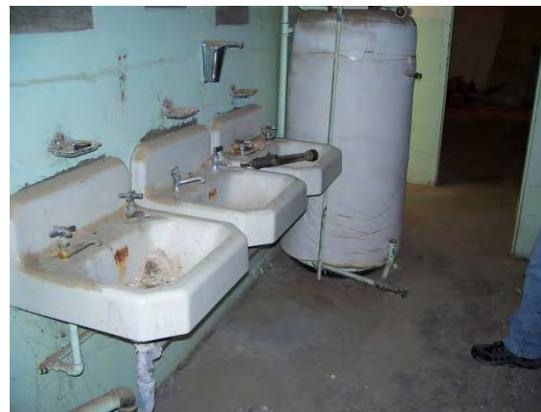
**Plumbing Code Violation- Building 11**

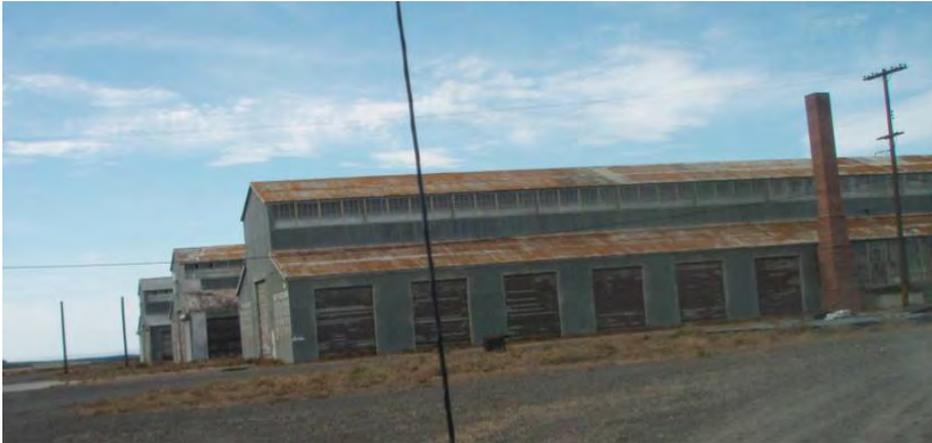
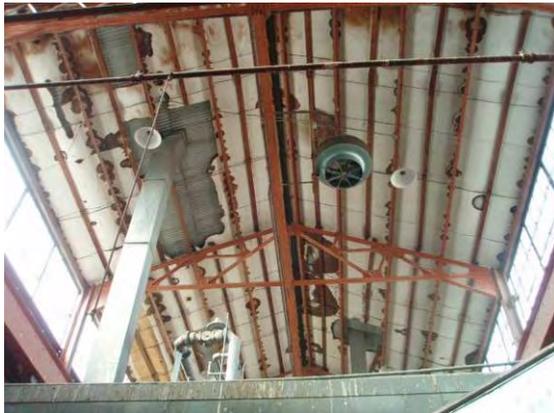
**Deteriorating Building**

The structural condition of the metal warehouses is questionable because the extent of oxidation is not known. If these facilities were stripped of their outer shells and decontaminated the remaining skeleton structure could be reused provided that a thorough structural analysis and inspection was conducted.

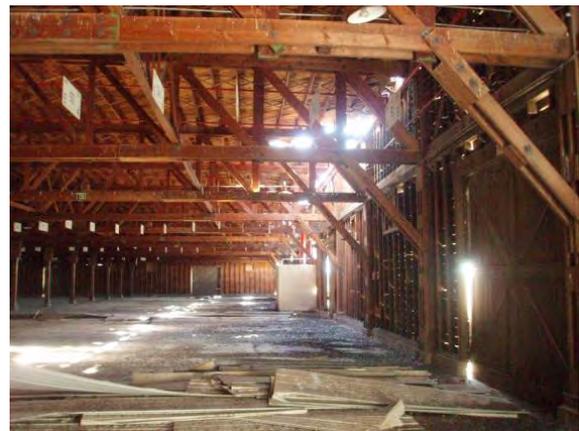
**Other/Notes:** Poor condition, open to atmosphere  
Typical 100 Series Warehouse Interior  
poor interior and exterior.

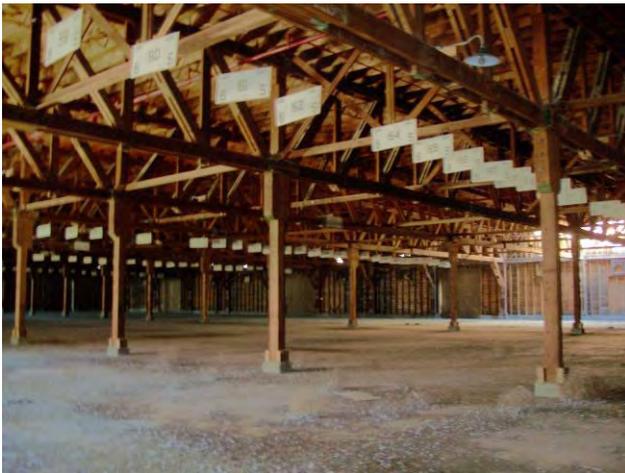
Typical interior without upgrades

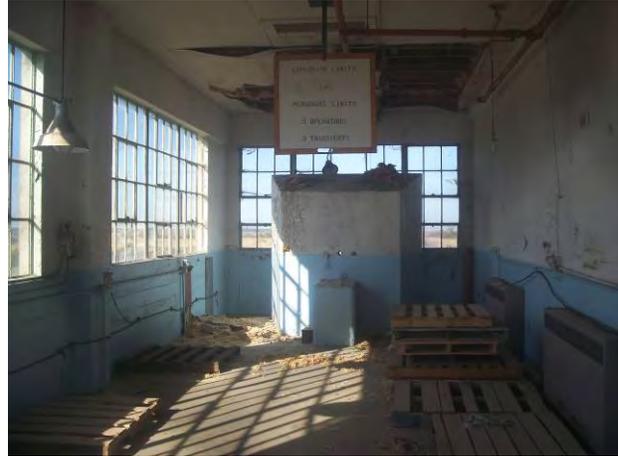
**Surveillance Workshop (failing roof & insulation)**
