Section A: Redevelopment Plan
Part II: Assessment Results

2.2: FACILITIES ASSESSMENT REPORT

ASSESSMENT COMPLETED: NOVEMBER 2009

EXECUTIVE SUMMARY: UMATILLA CHEMICAL DEPOT

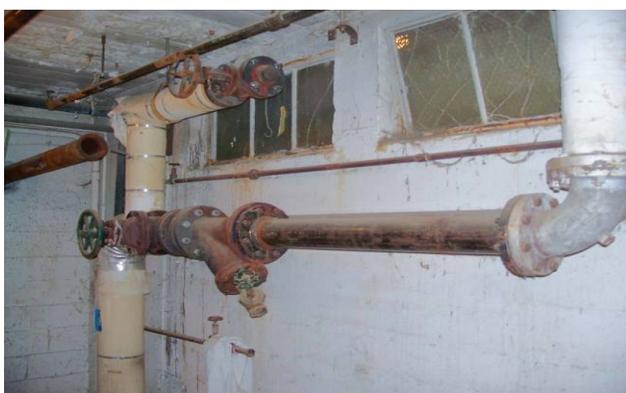
Piping Code Violation- Building 11 Basement

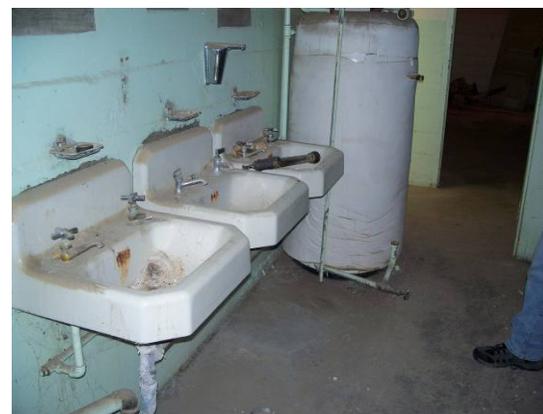
Plumbing Code Violation- Building 11

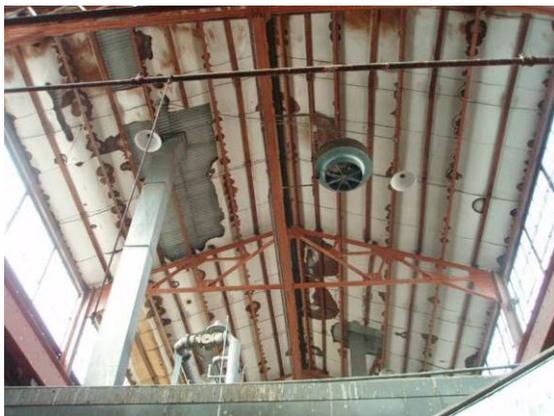
Deteriorating Building

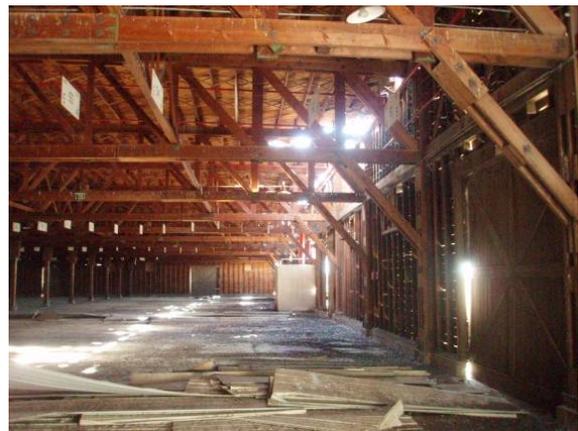
Other/Notes: Poor condition, open to atmosphere
Typical 100 Series Warehouse Interior
poor interior and exterior.

If not reused it is recommended that these structures be torn down and removed. If that alternative was selected, the buildings concrete foundations and loading docks could still be used for other purposes such as outdoor container storage.

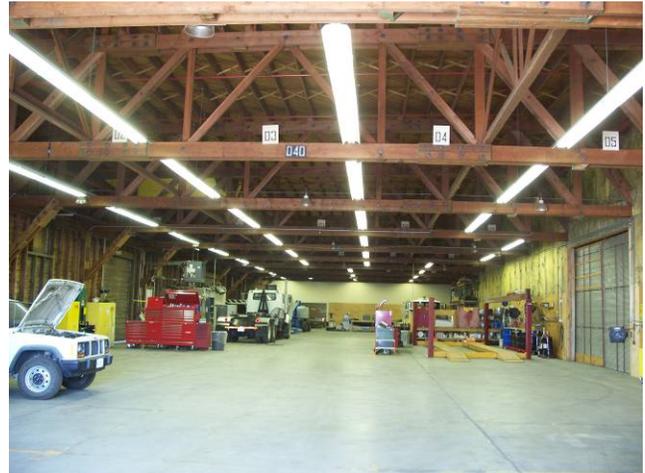
Re-used 200 Series Warehouse (New Lighting & Partition)

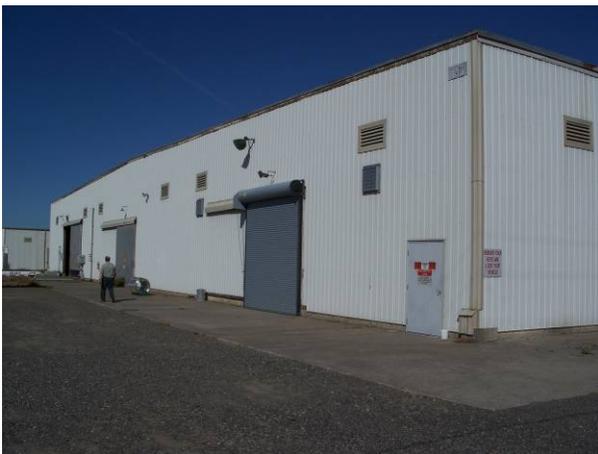
Re-used 200 Series Warehouse- (New Rollup Doors) -

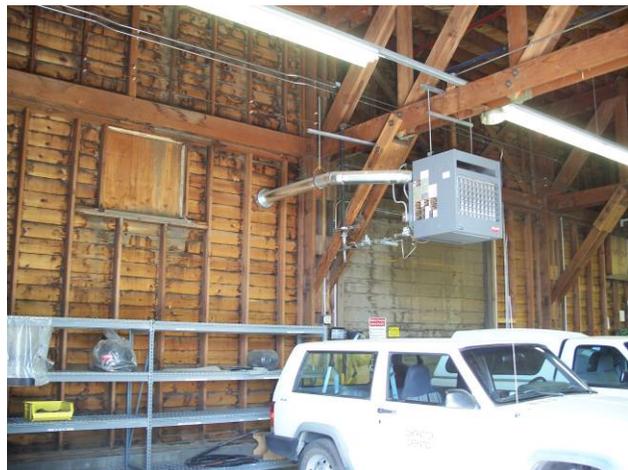
Re-used 200 Series Warehouse (New Unit Heater)

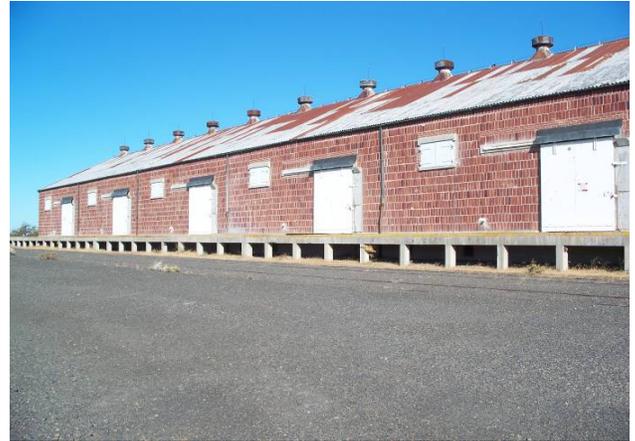
402 Building- Storage + Office -Refurbished

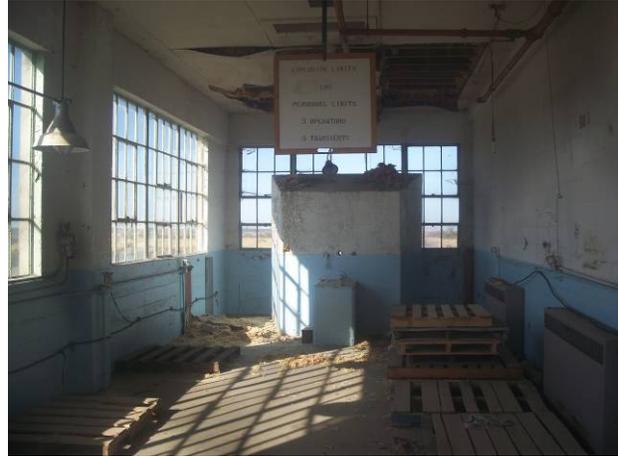
Surveillance Workshop (failing roof & insulation)
