Section A: Redevelopment Plan
Part II: Assessment Results

2.3: INFRASTRUCTURE

BACKGROUND INFORMATION & ANALYSIS

ASSESSMENT COMPLETED: OCTOBER 31, 2009

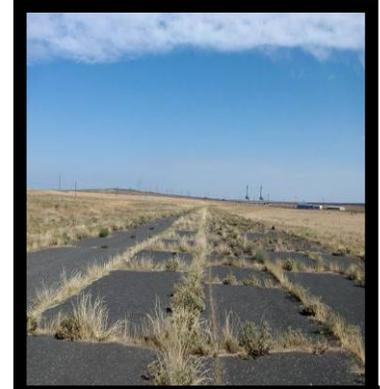
The runway was constructed by scraping the bare ground to its natural grade placement of 1-inch of crushed aggregate and a paved surface with a 1% cross slope for drainage. While the runway still exists, it has not been used for many years, primarily due to restricted base access and possibly restricted air space. The runway has significant cracking with weeds growing two to three feet tall that protrude from the cracks.

Airstrip looking Northeast

Recommendations: Save it and use it.

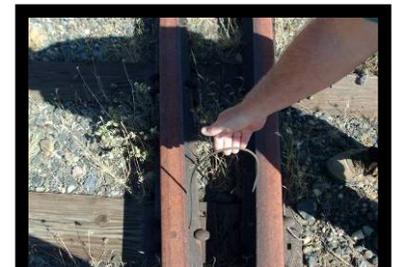
Ground Cable Connection between Tracks

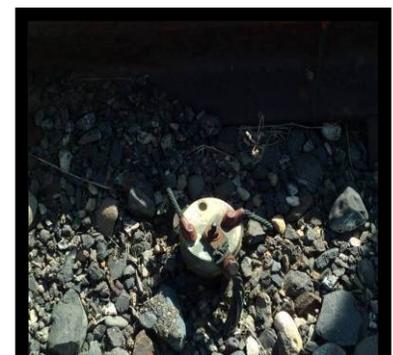
The ground system is in a deteriorated state. Ground wires have been broken and connectivity has been eliminated at various locations. Additionally, a portion of the railroad tracks (at the north east corner of the rail loop) have been removed. While the integrity of the full system has been compromised, the grounding system can still be used at various buildings. Each building needing a ground system in the future will need to have the system checked for electrical continuity.

Broken Cable Connector

Costs of surviving re-use alternatives: Cost of the ground system repairs is uncertain because of the potentially limited reuse. However, reconnection of the system at any building (assuming the system lacks continuity) is simply a matter of limited welding and possibly wire replacement.

Recommendations: Make future reuse business aware of the electrical ground system.

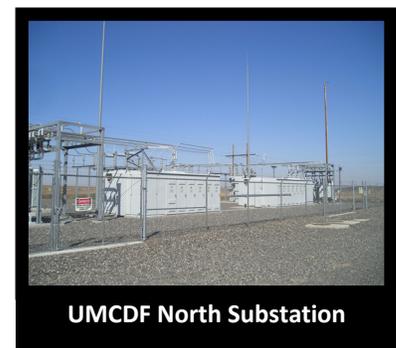
Power feed to the north areas of UMCD is separately fed from two redundant feeds to the UMCDF substation, coming from Morrow County (north feed) and Umatilla County (east feed). The newer feeds supply power to the UMCDF Chemical Disposal Facility substation, consisting of two redundant 12.5MVA/14MVA-4160/2400V OA/FA transformers. (Photo right)

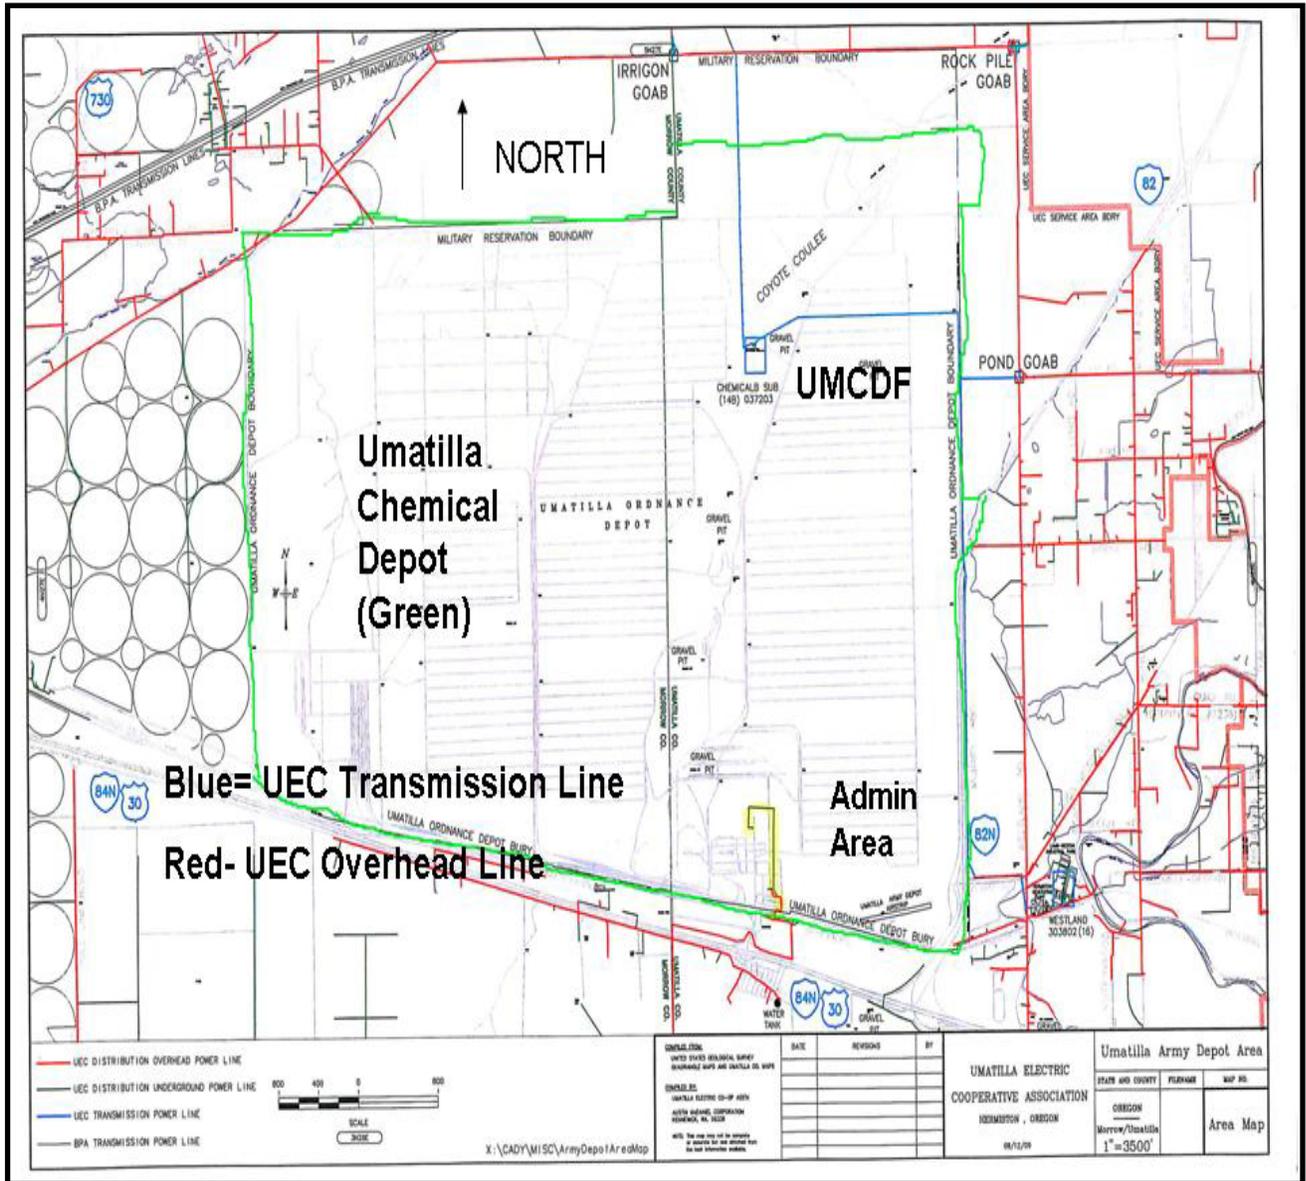
Figure 1: UMCD Power Grid

The third (south) power feed to UMCD is also fed by UEC at a distribution voltage 12.5KV, with maximum capacity of between 2-3 MVA (per UEC). This feed is currently fed and modified near the South Main Gate to function more reliably. The feed services the Administrative area, the 100 and 200 west warehouse areas (photo right) and 400 areas. The south UMCD power distribution system utilizes extremely old pole lines, and in some cases, underground replacement 12.5KV lines.

Electrical Recommendations: Identifying future usages must be done prior to redistributing the electrical distribution systems. Given the limited South Feed's capacity very little growth can be done with the current system with additional upgrades which would probably be in the millions of dollars.

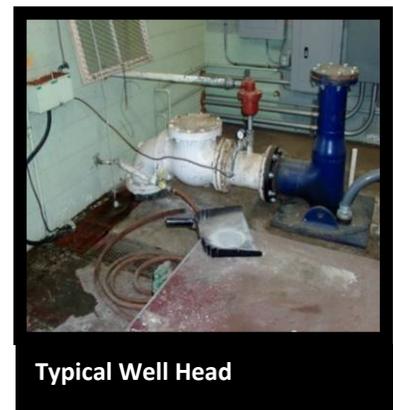
Typical Well Head

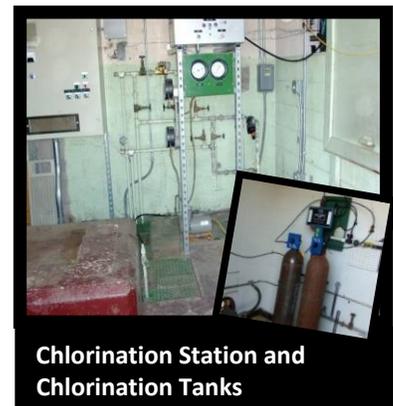
Chlorination Station and Chlorination Tanks

Environmental conditions & compliance: Chlorination areas appear to be maintained and in good working order.

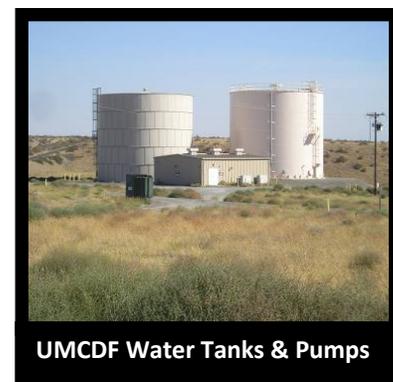
UMCDF Water Tanks & Pumps

This portion of the system was not reviewed in detail, other than to note its existence.

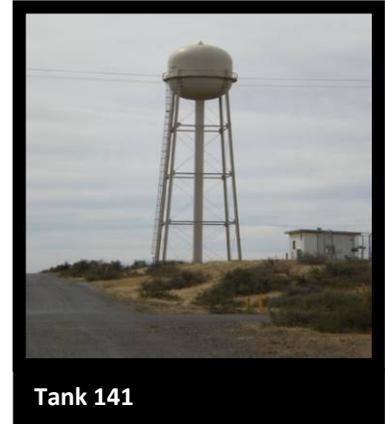
Tank 141

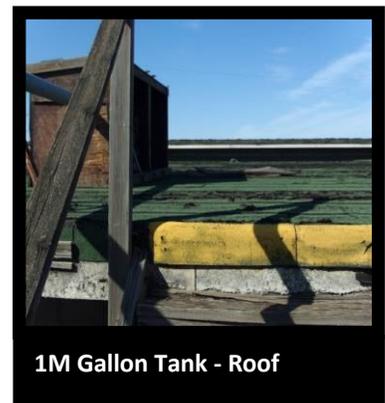
A large, above ground storage tank (1,000,000 gal) is present on site, and is not used due to the potential of contamination caused by low water usage. The tank could be re-used with modifications, as a fire protection reservoir if the need arose.

1M Gallon Tank - Roof

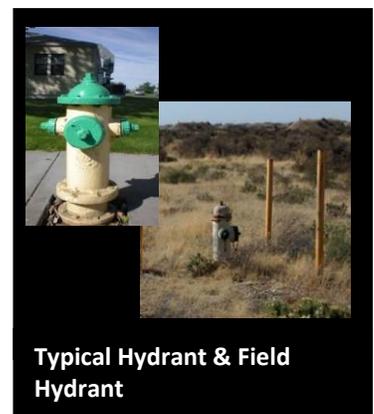
Fire hydrants are located within the Administration area and at other select locations within the facility branched from main distribution lines. While older, these units appeared to be in a maintained condition.

Typical Hydrant & Field Hydrant

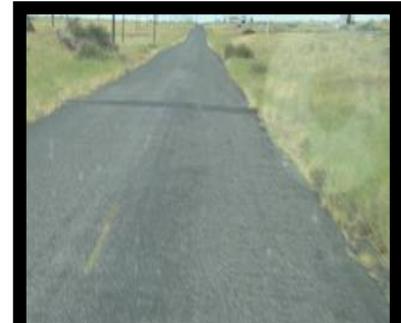
Roadway pavement on the base roads are in fair to good condition. Over the years, since construction in the early 1940's, the road surfaces have been maintained by patching potholes, repairing edge raveling and chip sealing and repaving the surface. The roadway pavement width generally is twenty four feet with limited or non-existent shoulders. The main road network is two lane and the roadways in the "Igloo's" is a single lane with pullouts for passing traffic.

Typical Roadways

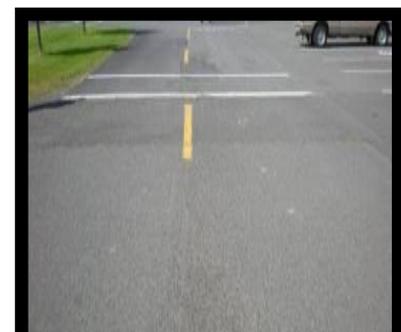
Typical Intersection

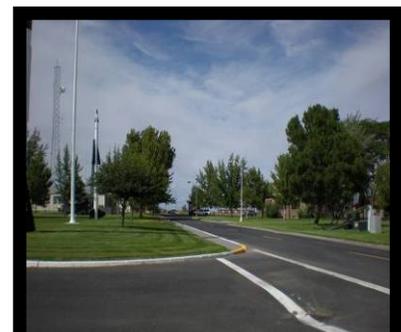
Roadways and parking areas in the Administration Area lack definition between them. Roadway pavement and parking lot pavement often meet in ways that limit appropriate roadway access control. While there is limited curbing in the Administration Area

Administrative Area
Streetscape

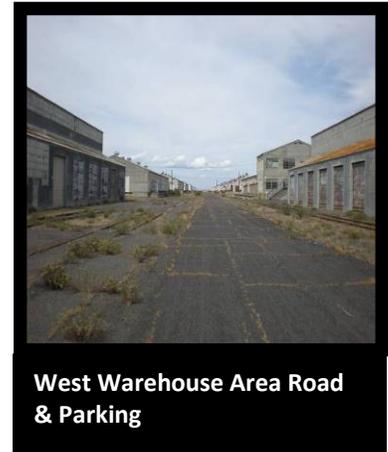
West Warehouse Area Road & Parking

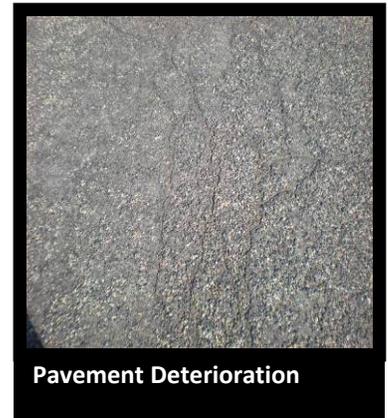
Inspection and observations (positive aspects, deficiencies and damage): The roadway pavement is in good condition. Base staff has repaired pavement damage, such as edge raveling or potholes, and kept the pavement in good condition. Additionally, there is evidence of a chip seal overlay on certain road pavements and the UCD base public works staff continues to contract with local paving companies for new pavement overlays.

Pavement Deterioration

Recommendations: Determine an appropriate road network for reuse and establish a maintenance budget.

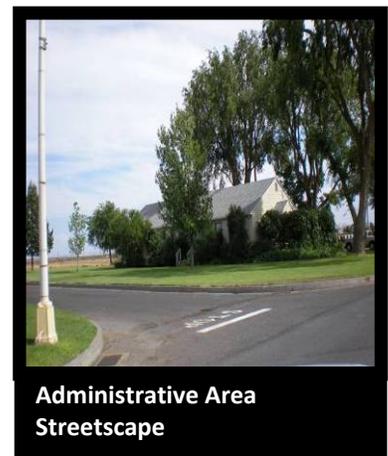
Administrative Area Streetscape

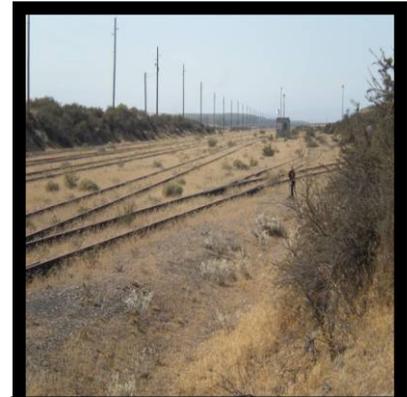
There are three siding rail yards along the southern boundary of the base. These yards are parallel with the main line of the Union Pacific Railroad (UPRR) and serve as rail car storage for transports between the UPRR and the base. The last usage of the siding yards was during Desert Storm and the system has not been maintained since. There are locations of obvious deterioration and prior to any reuse the integrity of the rail system to be used will need to be validated. Additionally a section of the on-base rail track has been removed at the north east corner of the rail loop. Other sections of track have been asphalt covered where roads and rail cross. Those crossings would need to be reconnected or reconstructed prior to reuse considerations that require the track layout.

Classification Yard

Recommendations: The rail system is mostly intact and has potential for beneficial reuse. Reconnection to the Union Pacific Railroad should be considered and the rail system evaluated to determine its capability of handling current rail traffic.

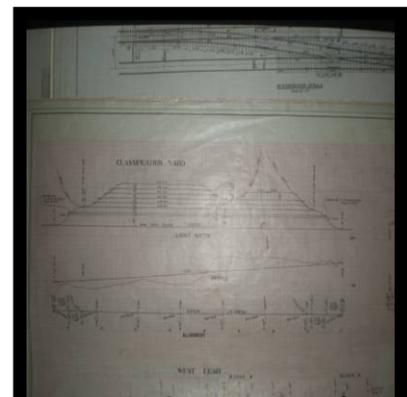
Classification Yard Drawing

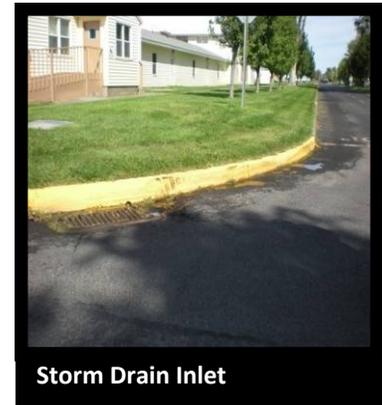
The entire piped drainage system is well beyond its useful life and will need to be replaced with any reuse.

Storm Drain Inlet

Recommendations: Replacement of the storm drainage system needs to be considered in the near term.

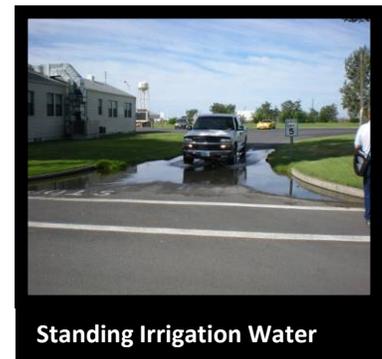
While the Administration area has good drainage there are locations in the roadway where drainage puddles. This was observed from over irrigation of the landscaping.

Standing Irrigation Water

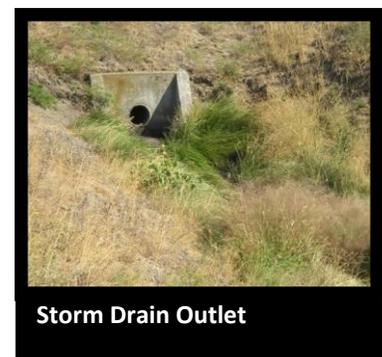
Storm Drain Outlet

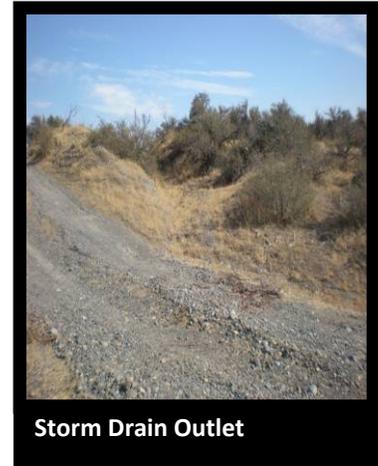
Storm Drain Outlet

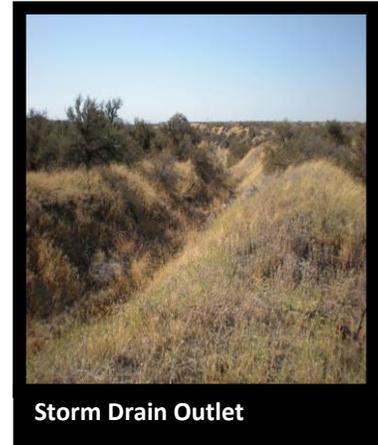
Storm Drain Outlet

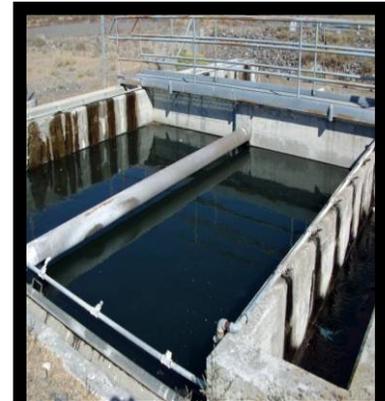
Large Imhoff Tank

Inspection and observations (positive aspects, deficiencies and damage): The Imhoff tank area was inspected on September 16. The larger of the two systems is currently in use and seems to be functioning well. The amount of load on the system is estimated at less than 10 percent of the design capacity. There was no sewer gas smell emanating from the system in use, and scum buildup in the vent area was minimal.

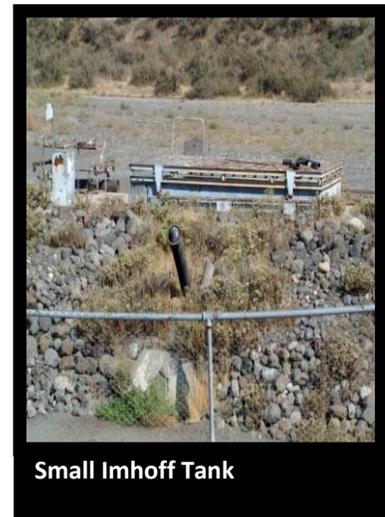
Small Imhoff Tank

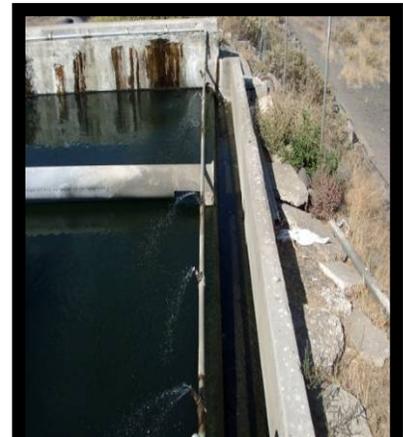
Large Imhoff Detail

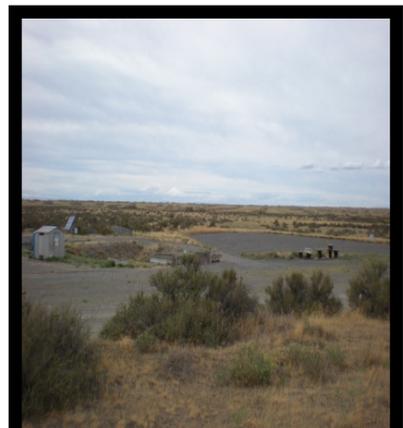
Drain Field Area
