## **SECTION 2.2: FACILITIES ASSESSMENT REPORT**

**ASSESSMENT COMPLETED: NOVEMBER 2009**

## EXECUTIVE SUMMARY: UMATILLA CHEMICAL DEPOT

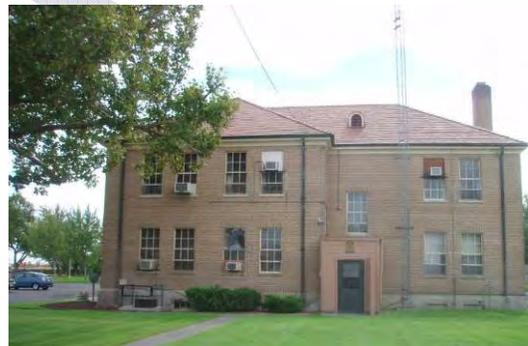
**North Elevation**

No front accessible access, Not handicap accessible, Vinyl Asbestos Tile, Concrete and terrazzo floors, cast-in-place concrete construction throughout, interior Concrete Masonry Unit (CMU) in basement, vault in basement. Red clay tile roof, copper flashing and gutters in good condition.

The roof appears to be asbestos composite or red clay tile (original). The roof condition, with some visible weathering, could remain acceptable indefinitely.

A comprehensive structural evaluation is needed to qualify the building for re-use. Electrically this building needs to be inspected for updated electrical wiring and panels plus the replacement of old fixtures, receptacles, switches and the addition of new capacity for the addition of newer office equipment which may require surge protection and additional capacity.

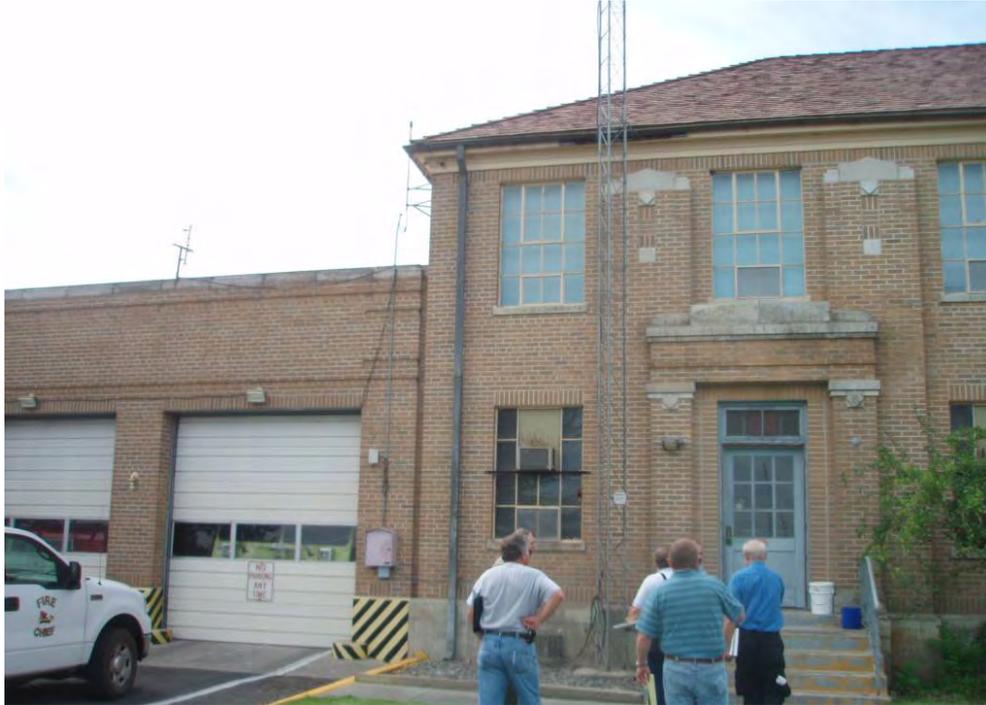
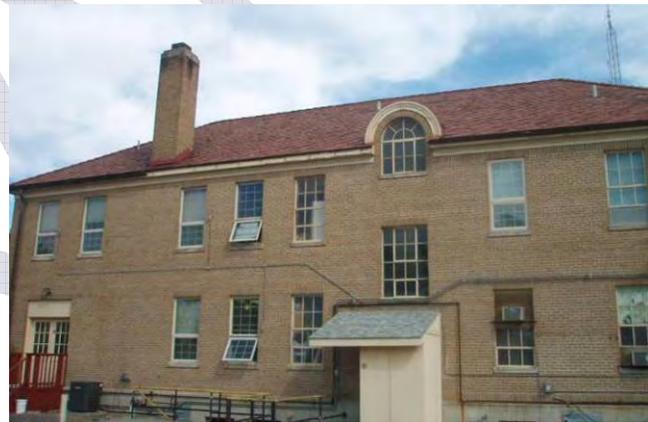
East Elevation

Typical red tile roof and brick. Copper flashing and gutters. Engine bays are very tight and constricted, minimal clearances throughout, asbestos flooring (VAT found throughout, especially in basement), encapsulated asbestos and lead paint expected throughout the entire building. No fire-rated doors, all surfaces worn. Not sprinklered. Dormitory on second floor. Very little insulation in walls and minimal in roof

The two story building has timber trusses. The roof on the two story building appears to be asbestos composite or red clay tile (original). The two story building roof condition, with some visible weathering, could remain acceptable indefinitely.

Contact State of Oregon Historical Preservation Organizations, and determine their possible interest to acquire and maintain the building.

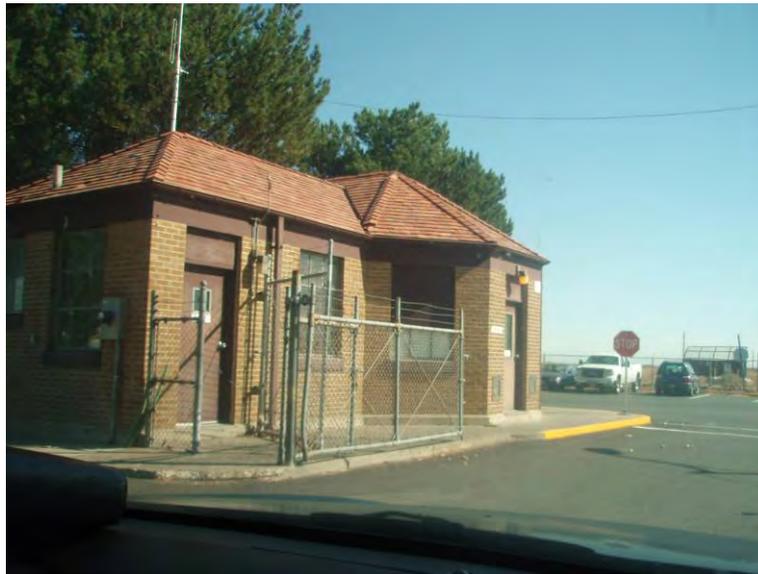
**South Elevation**

NFPA 70, NEC date of revision not found.

This building may need inspection on the wiring inside the conduits to see if it needs replacement. Depending on the future usage a UPS may be needed to keep continuous power on the access control and personnel accountability system with additional equipment cooling.

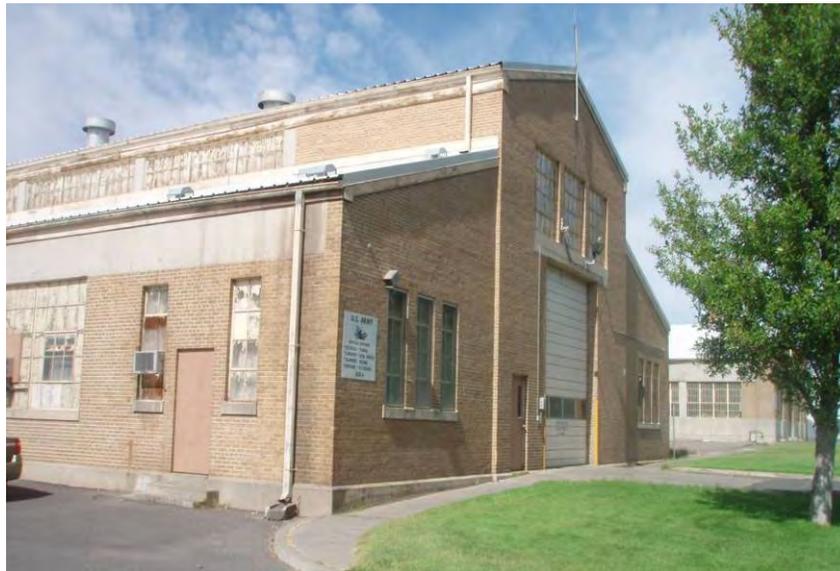
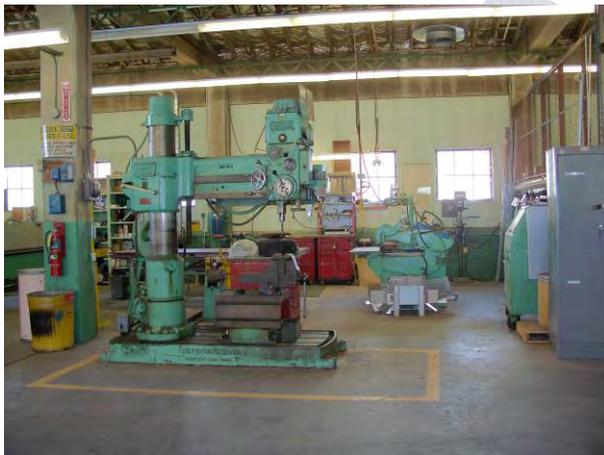
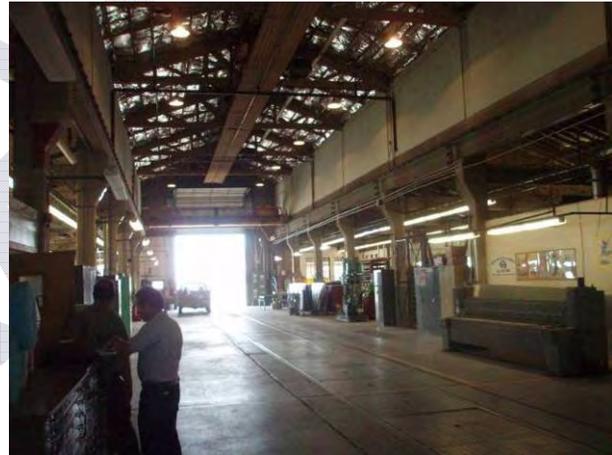
**MaintenanceShop Building**

In overall good condition.

Electrically this building has been upgraded with new power panels and been maintained fairly well. There are some questions about the status of the wiring but the raceway appears to be Rigid Galvanized Steel Conduit. The lighting should be looked at to be more efficient types. It appears the pad mounted transformers for the area were also replaced when the distribution went from 4160 V to 12.5 KV. The shop electrical machine tools were also functional and appeared to be in good shape.

Use as is as a maintenance shop and revise as needed for the future mission. This could easily be a part of a technical school training program. It is recommended to keep the shop in use, update the doors, and provide access and handicap restroom fixtures. A comprehensive structural engineering evaluation is needed to qualify the building for re-use.

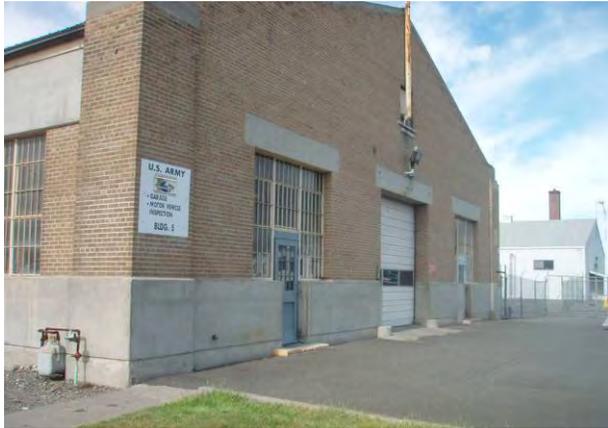
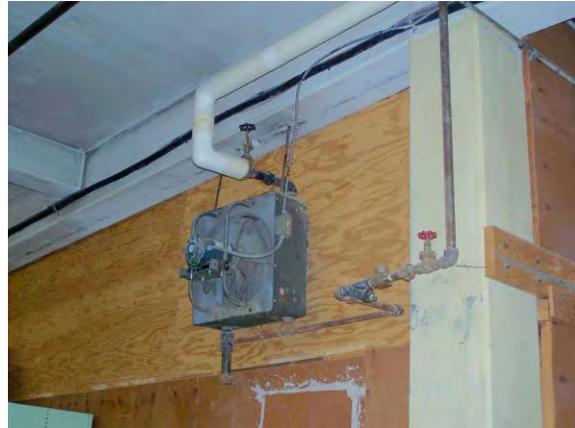
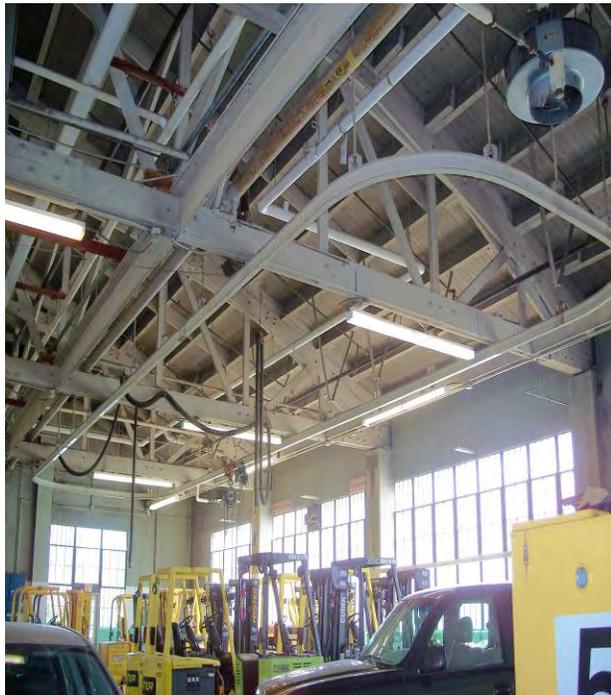
**East Elevation**

In overall good condition. The building is a currently used vehicle maintenance shop.

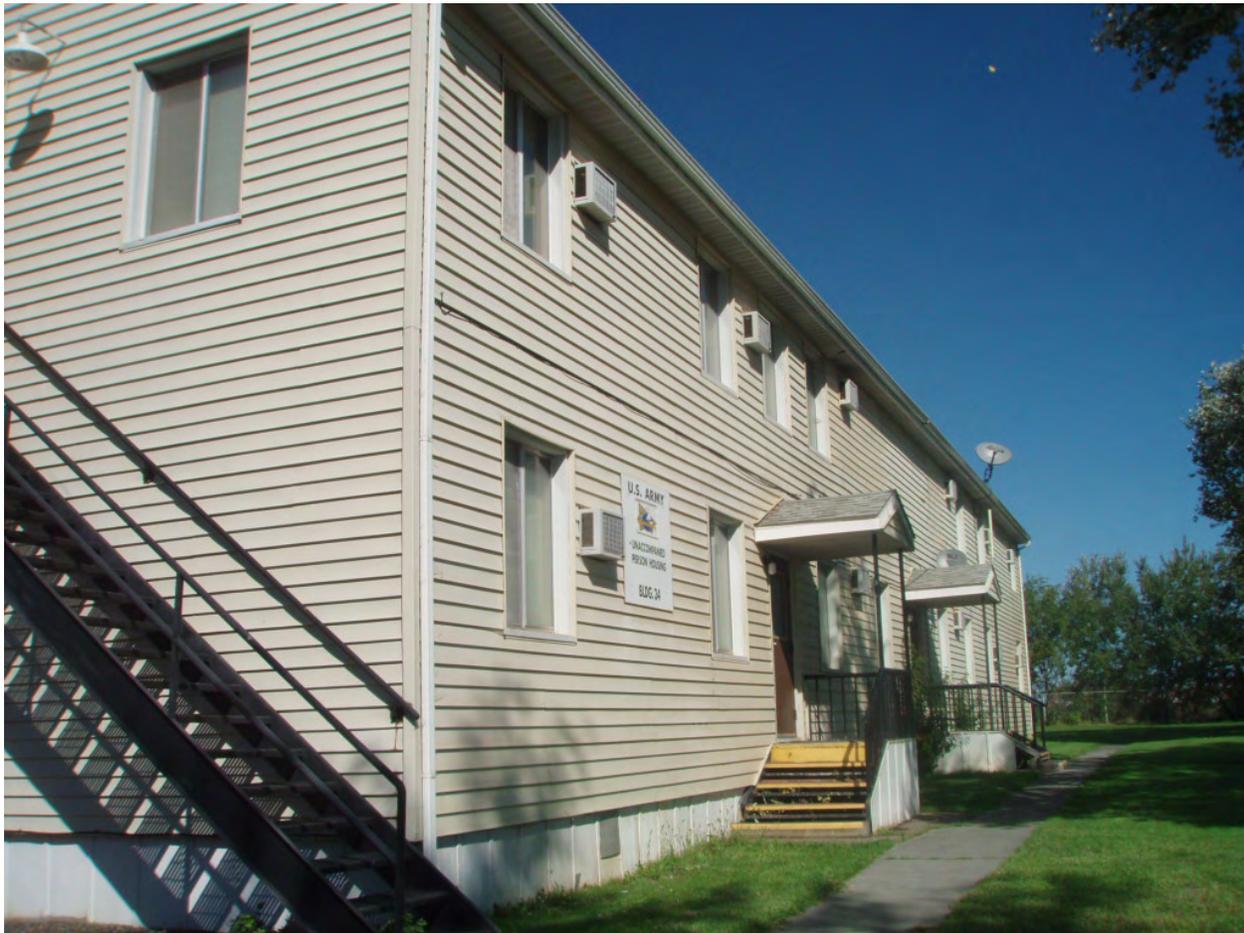
East elevation

Access ramp to 1<sup>st</sup> floor. New south exterior stair to 2<sup>nd</sup> floor. Back exiting stairs signed unsafe. North exit stairs appear to be unsafe. Likely no draft-stops are installed. No protected stairwell

from south end of second floor. Vinyl asbestos tile (VAT) noted on second floor and (CAB) cement asbestos board noted under vinyl siding.

The interior of this building was not inspected. Cement asbestos board (CAB) was noted at exterior walls the building has replacement vinyl siding covering the CAB. Window shaker air conditioning units are installed. This exterior of this building appears to be kept in better shape than the Recreation Center

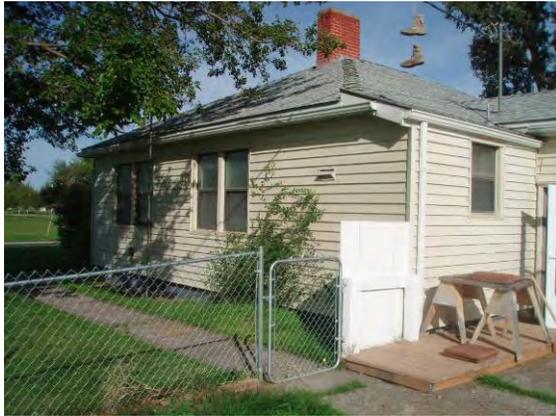
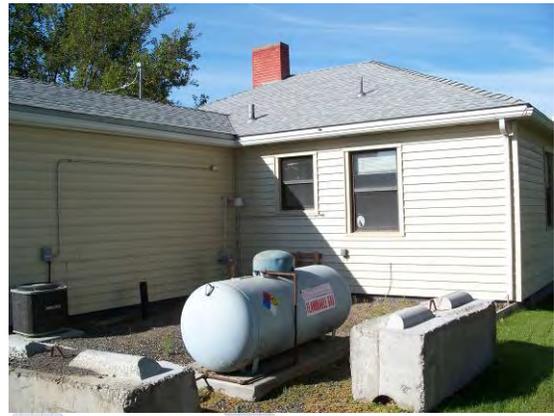
**House #35- Southeast corner**

**House #35 Northwest corner**

The house is in very poor condition, with the interior in bad shape. The house is currently vacated. There are no landscaping and outdoor yards with fenced privacy.

Molding and interior paint are poor condition. It has replacement vinyl siding. The roof is composition shingles (new). House has double pane windows. Hard floors have vinyl tile containing asbestos. Garage may have value as a storage shed. It has hardwood floors that appear in acceptable condition. There have been recent modest low quality interior refurbishments, including repainting, and kitchen flooring. On the negative side, the property is infested, and has reached the end of its service life.

Plan and schedule demolition. Tear down and could use external services for a mobile home reconnection.

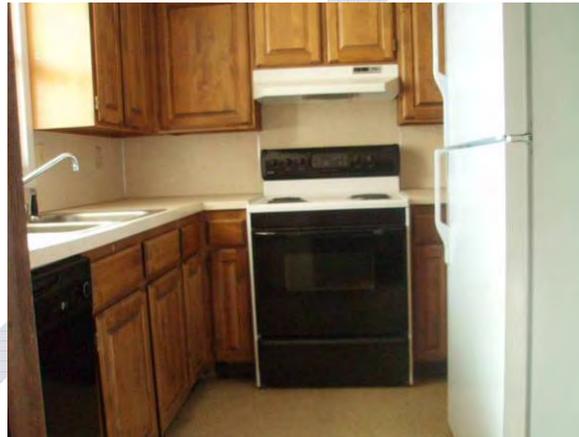
**Kitchen at three steps up from utility room**

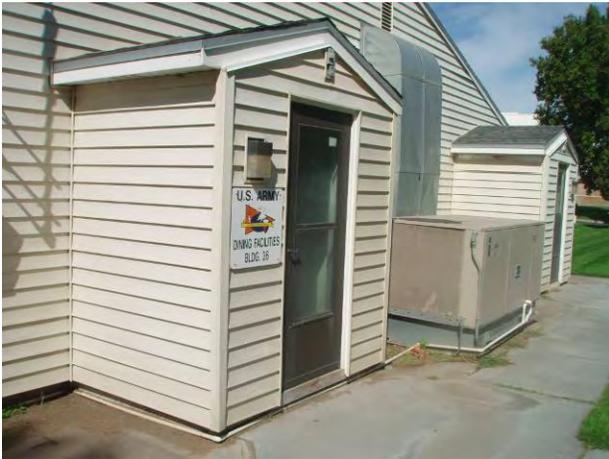
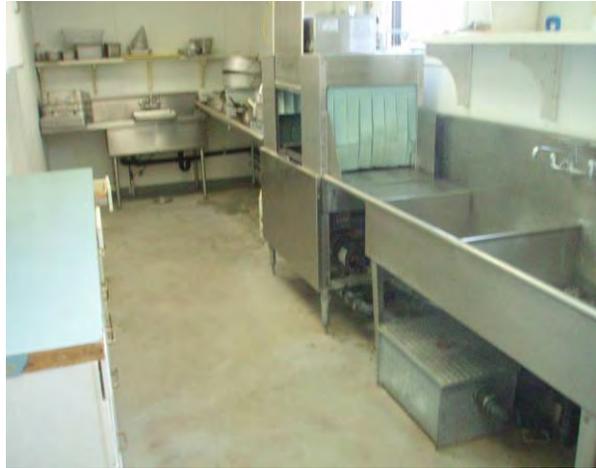
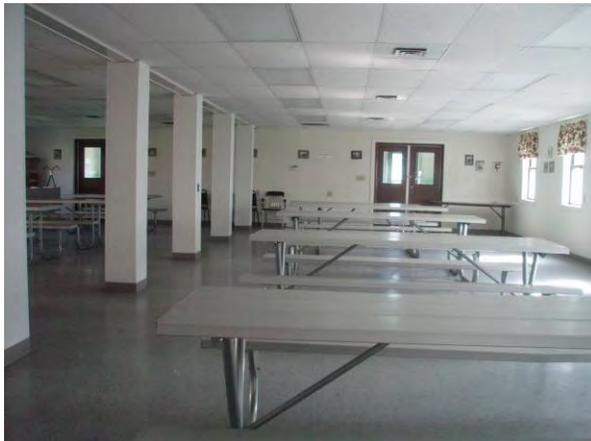
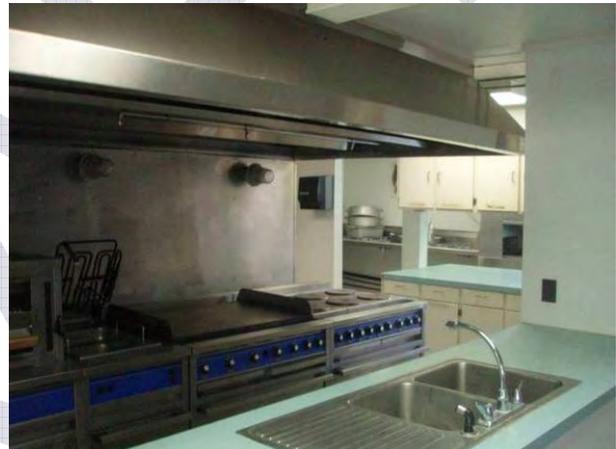
The building appears to be in good condition. This is a group of small buildings combined into a single story dining facility. The building and kitchen were refurbished on an expedited basis in late 2001, in order to re-establish its use as a military dining hall. The dining hall is now in-active.

Wall substrate may be cab and these could be lead paint encapsulated under newer coatings. The kitchen with the exception of the Formica counters appears to be in very good shape. The walk-in freezer and refrigerator are located outside the kitchen on the south side. The dining area is nice and pleasant. The building has replacement vinyl siding with composition shingle roofing. Restrooms are upgraded and in good condition.

The building has a very nice kitchen, intact and is ready for use. Structurally, the building is recommended not to be modified.

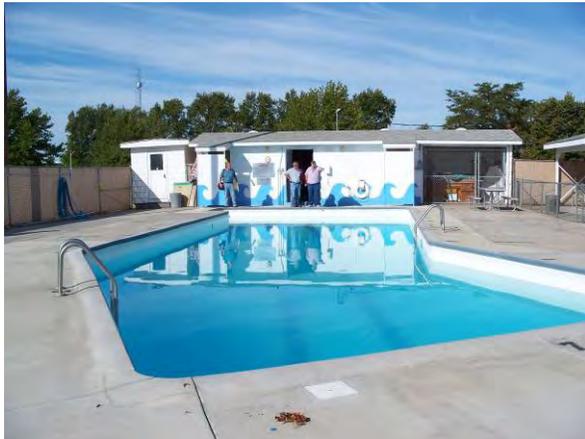
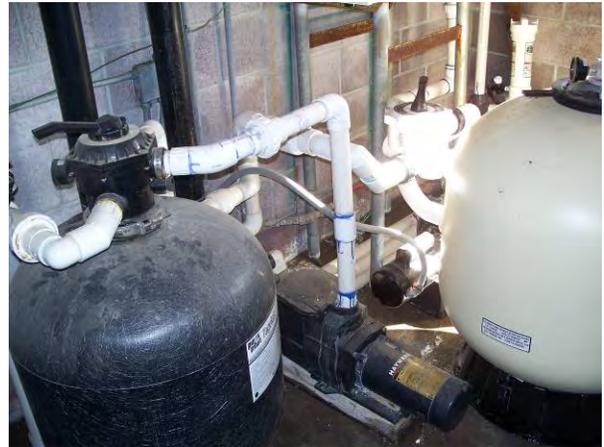
**Swimming Pool**

**Pool Pumping & Filtration System**

The rooms were very tight, even for non-handicap people and the floor levels changed within the small spaces. The pool building and pool area are in generally rough condition. Beetle infestation was noted. The pool was upgraded to new drain configuration requirements. The pool and concrete deck in good condition. The hot tub is filled with sand and not used. The pool has space for poolside relaxation, including covered picnic tables and benches. The storage building is in poor condition. The restrooms and changing rooms are in poor condition, very tight with floor elevation changes, very poor restroom layouts and accommodations for swimmers. The shelter is in good condition. There is no insulation.

Replace or add to existing building to accommodate swimmers. Rewire the new building to house the new mechanical room and change rooms plus add outdoor lighting around the pool area for safety. Reinstall the main panel to comply with the electrical clearance issues. The potential for covering this pool with an air inflated cover for winter use might also be considered for year round use if that is to be considered. Also a pre-engineered metal building covering could also be considered.

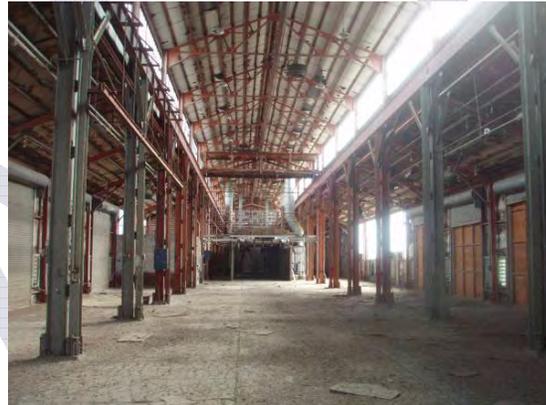
**100 Series – Metal – looking south**

The structural condition of the metal warehouses is questionable because the extent of oxidation is not known. If these facilities were stripped of their outer shells and decontaminated the remaining skeleton structure could be reused provided that a thorough structural analysis and inspection was conducted.

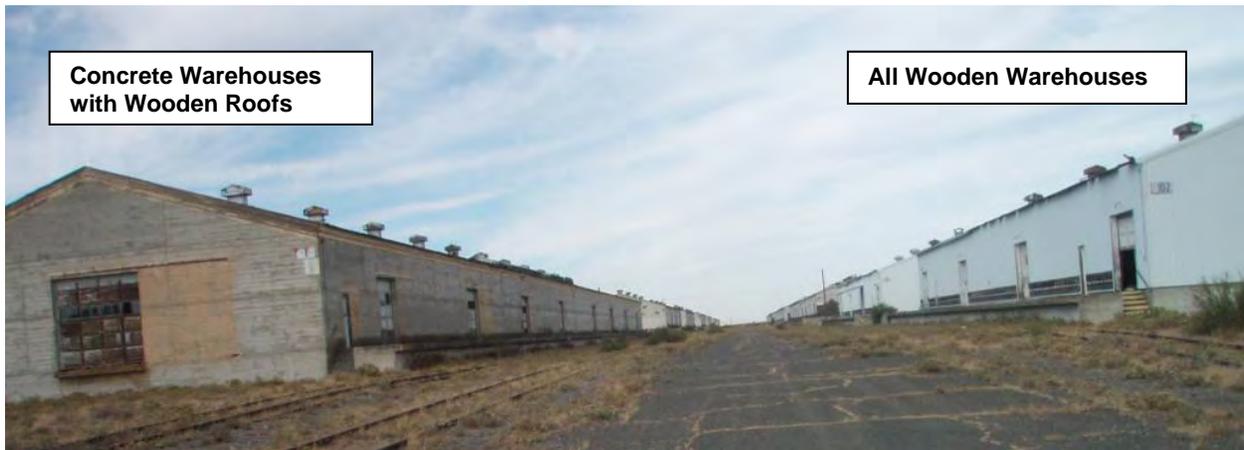
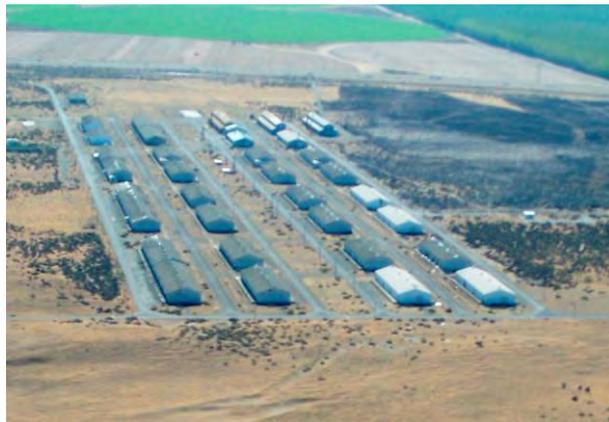
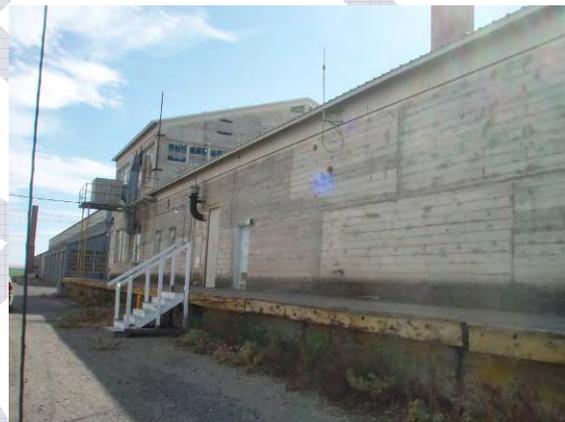
100 Series Warehouses Looking North

If not reused it is recommended that these structures be torn down and removed. If that alternative was selected, the buildings concrete foundations and loading docks could still be used for other purposes such as outdoor container storage.

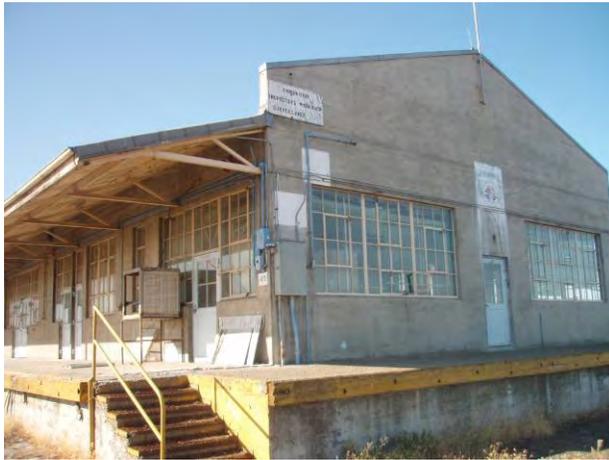
**Surveillance Workshop #415**  
**#415**

Buildings are in extremely poor condition. Numerous violations of codes and standards are prevalent throughout. The Surveillance Workshop and old Breakroom building are not accessible.

Buildings are very rough and not useable. Surveillance building could be used with extensive upgrading, but the Boiler Bldg and the Break room are structurally and environmentally hazardous. Leaky roofing and failing siding and windows has led to intrusion of the elements and pigeons resulting in widespread deterioration. Electrical systems are very poor condition and not feasible to re-energize.

These buildings should be completely torn down and removed.

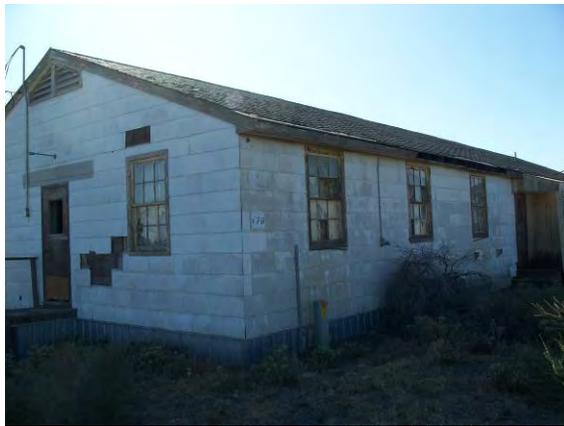
**Breakroom Building**

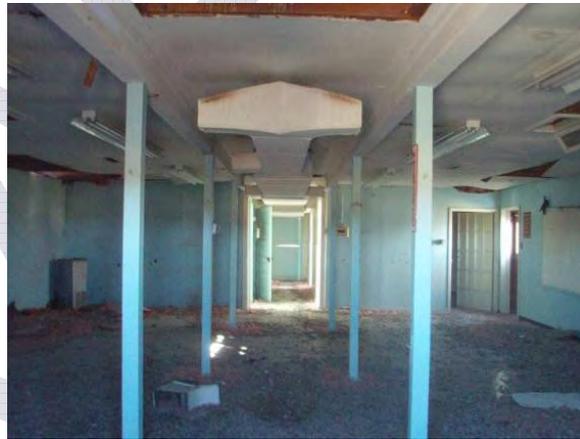
**Breakroom Building**

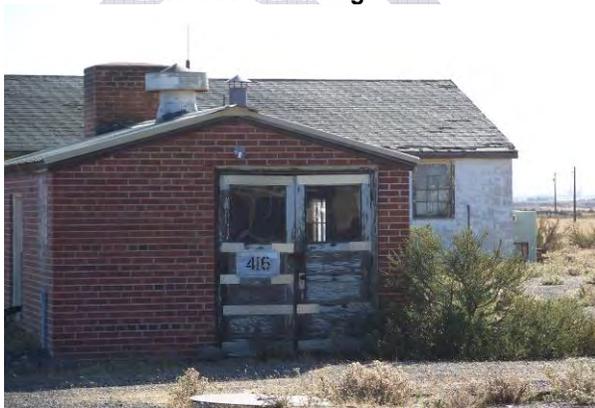
**Boiler Building**

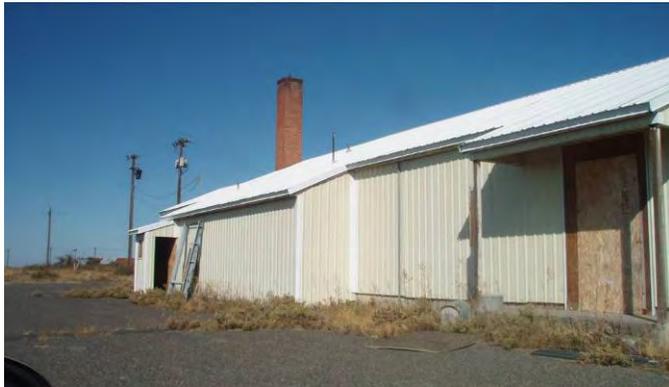
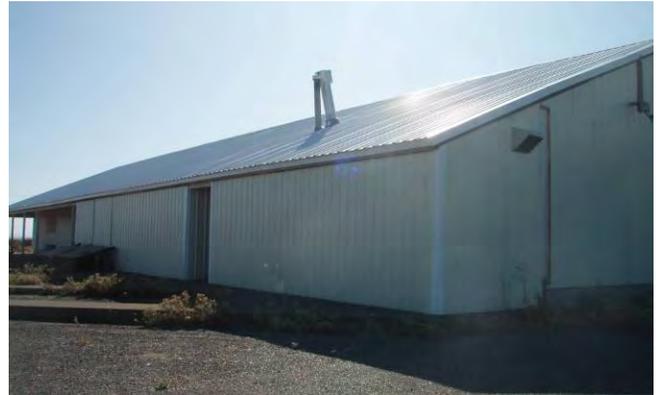
**Ammo Operations Breakroom Building – North**

**Ammo Operations Breakroom Building – South**

Building 419 is in extremely poor condition. It is expected that numerous violations of codes and standards are prevalent throughout. Building 419 was not accessible and is not in use.

Building 419 is very rough and not useable. According to the Army representative, the building has new siding but is otherwise in very bad condition inside. It was used as breakroom and laundry. The building had a wash-down area, chemical cleanup before K-Block and old showers. The building likely possesses a mix of hazardous chemicals, lead paint and asbestos. It was used up to 9/11 and then used for siege practice, and contains lots of paintball paint on the walls.

The Ammo Operations Breakroom Building Building 419 should be torn down and not reused.

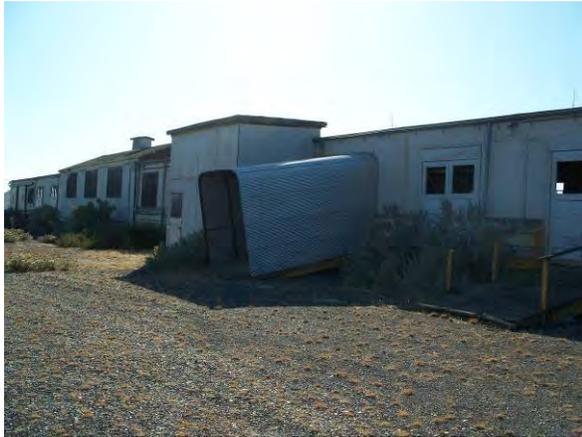
**Ammo Operations Building**  
(West bldg- North side)

**Other/Notes:** The “Ammo Operations Building”, “Boiler Building” and “Less than a truckload” Building” are all in very poor condition.

Buildings are in very poor condition and codes and standards cannot even be considered. Electrical is not in service. Structurally and environmentally, the buildings are hazardous.

Buildings are very rough and not useable. Metal, Concrete wood trusses and asbestos has been noted.

Buildings 431, 434 and 433 (“Ammo Operations Building”, “Boiler Building” and “Less than a truckload” Building”) should be torn down.

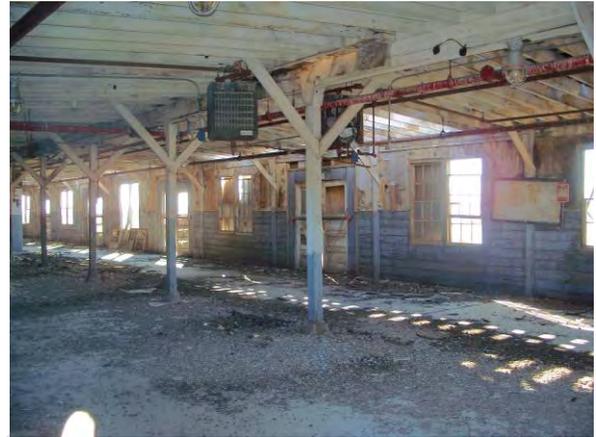
**Less Than A Truckload & Boiler Plant Building**  
(East bldg- inside)

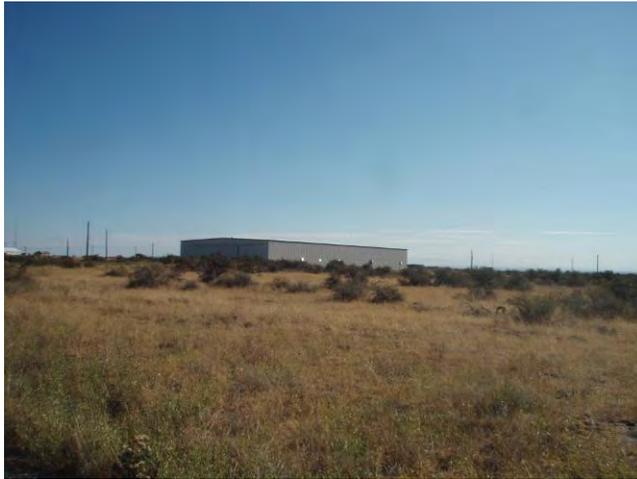
**Bldg #450 West elevation**

This building is used for RV storage only. The current structure is a pre-engineered metal building. No heating is available in the building and no insulation is in the ceiling or the walls. The sky lights in the roof give good lighting for RV Storage. The building has not exit lights or egress light and can only be accessed in night time with a flashlight. The only receptacles found are located next to the power panel on the Northwest corner. There is also a 1 ½" fire pipe connection and a hose connection which did not appear to be charged with water. There is a potential for RV spills on the floor spaces. There is also a fire potential from stored vehicles. There are extensive outdoor parking spaces. The roads are in very poor condition but passable.

Continue with current use or remodel for new use, storage, warehouse, offices with high-bay. At a minimum exit light and limited egress lighting for night access should be added.

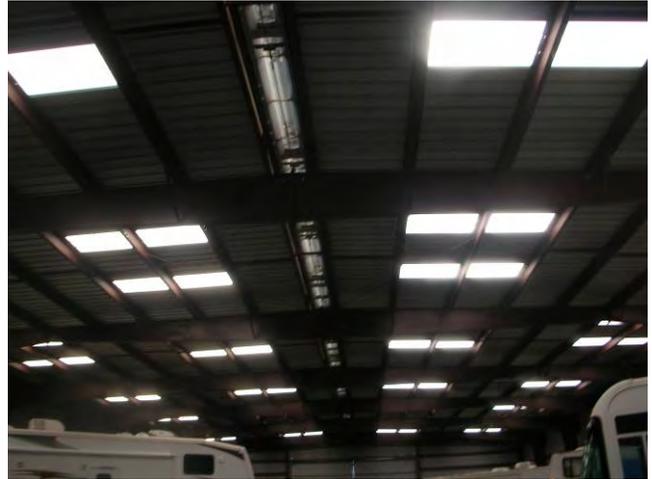
**Bldg #450 (Skylighting only; automatic roof vents)**

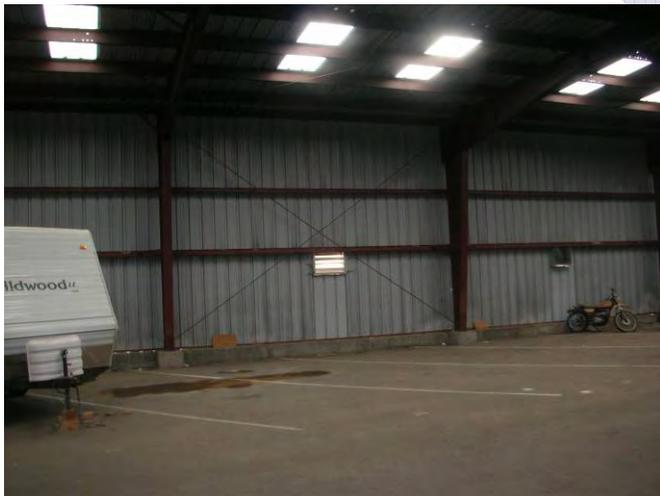
**Bldg #450 Typical RV Storage**

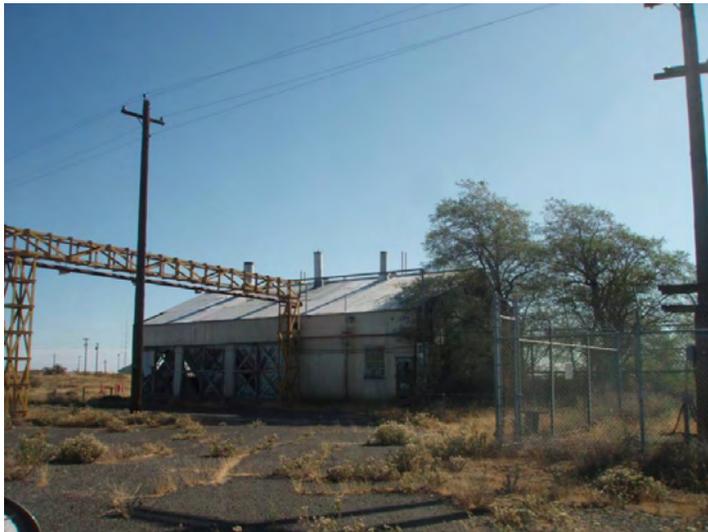
East elevation

**Year Built:** 1953 **Sq Ft:** 1000  
**Asbestos:** Not Detected **Biological Hazard:** Yes  
**Lead Paint:** Not Detected  
**Other/Notes:** Very poor condition

**Architectural:** This building is in very poor condition. The condition of this building precludes any conformance to building codes and standards.

The building is very rough and not useable. Metal, Concrete wood trusses and asbestos were observed.
