Section A: Redevelopment Plan
Part II: Assessment Results

2.2: FACILITIES ASSESSMENT REPORT

ASSESSMENT COMPLETED: NOVEMBER 2009

EXECUTIVE SUMMARY: UMATILLA CHEMICAL DEPOT

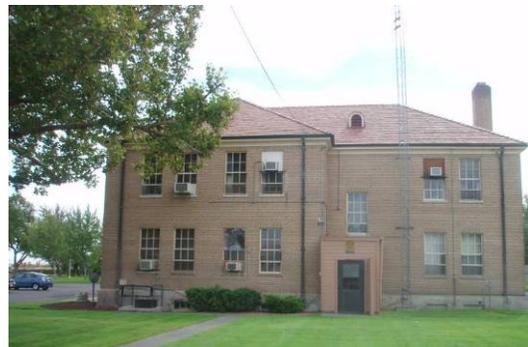
North Elevation

Current Overall Condition: 1 2 3 4 **5** 6 7 8 9 10 Poor-Excellent

Window air conditioners are used. Building has older plumbing throughout and has no fire sprinkler system.

No front accessible access, Not handicap accessible, Vinyl Asbestos Tile, Concrete and terrazzo floors, cast-in-place concrete construction throughout, interior Concrete Masonry Unit (CMU) in basement, vault in basement. Red clay tile roof, copper flashing and gutters in good condition.

The roof appears to be asbestos composite or red clay tile (original). The roof condition, with some visible weathering, could remain acceptable indefinitely.

Older plumbing is prevalent throughout. There is no sprinkler system. The air conditioning system is inadequate, requiring window air conditioners. Radon has been previously detected in the basement, and for this reason the basement is now well ventilated.

No changes are recommended other than handicap and occupant safety upgrades.

A comprehensive structural evaluation is needed to qualify the building for re-use. Electrically this building needs to be inspected for updated electrical wiring and panels plus the replacement of old fixtures, receptacles, switches and the addition of new capacity for the addition of newer office equipment which may require surge protection and additional capacity.

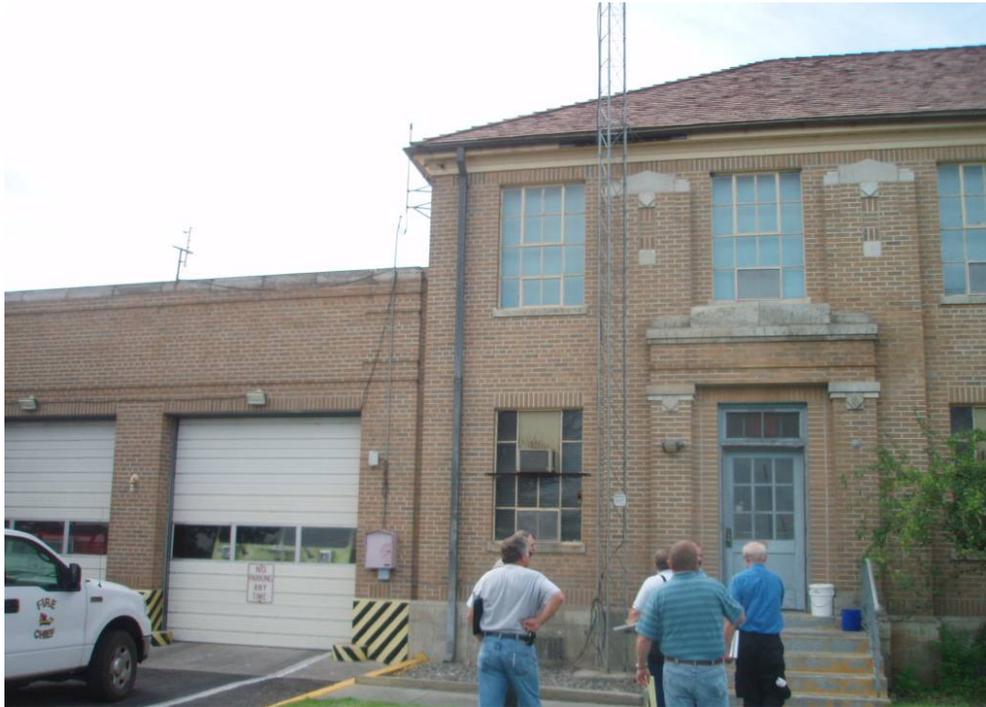
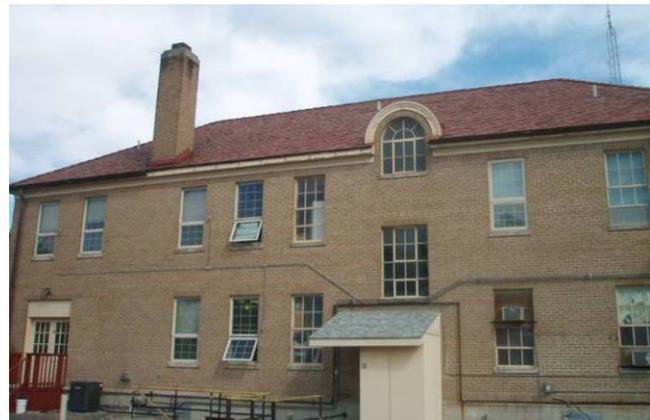
Current Overall Condition: 1 2 3 4 **5** 6 7 8 9 10 Poor-Excellent

Typical red tile roof and brick. Copper flashing and gutters.
Engine bays are very tight and constricted, minimal clearances throughout, asbestos flooring (VAT found throughout, especially in basement), encapsulated asbestos and lead paint expected throughout the entire building. No fire-rated doors, all surfaces worn. Not sprinklered. Dormitory on second floor. Very little insulation in walls and minimal in roof

The two story building has timber trusses. The roof on the two story building appears to be asbestos composite or red clay tile (original). The two story building roof condition, with some visible weathering, could remain acceptable indefinitely.

The firehouse building is air conditioned. Older plumbing is observed with typical galvanized piping and typical cast iron drain piping. The building has no fire sprinklers.

Contact State of Oregon Historical Preservation Organizations, and determine their possible interest to acquire and maintain the building.

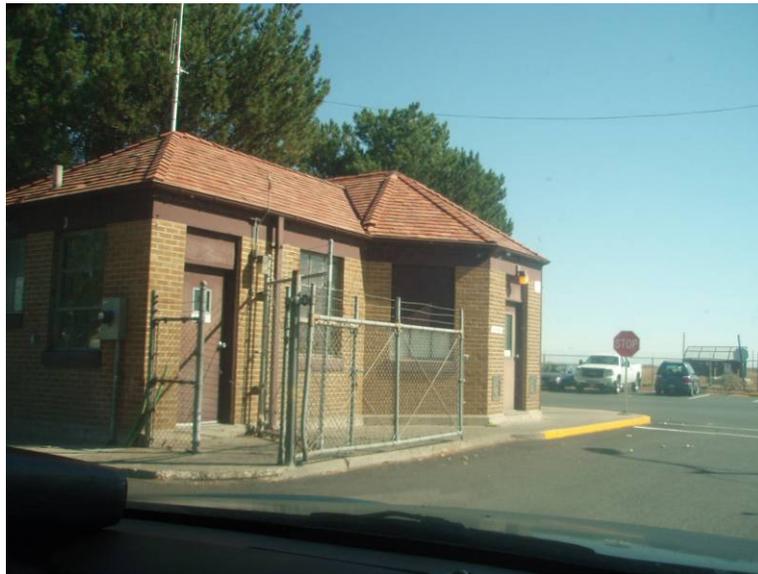
South Elevation

Current Overall Condition: 1 2 3 4 **5** 6 7 8 9 10 Poor-Excellent

This building may need inspection on the wiring inside the conduits to see if it needs replacement. Depending on the future usage a UPS may be needed to keep continuous power on the access control and personnel accountability system with additional equipment cooling.

Handicap and occupant safety upgrades may be required.

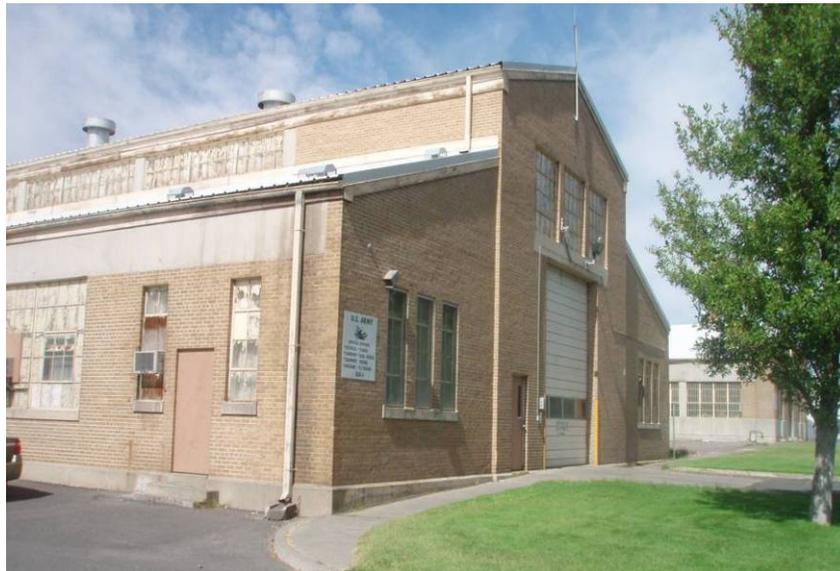
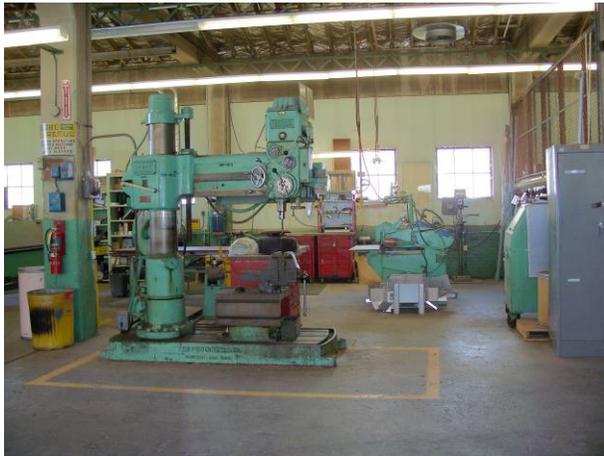
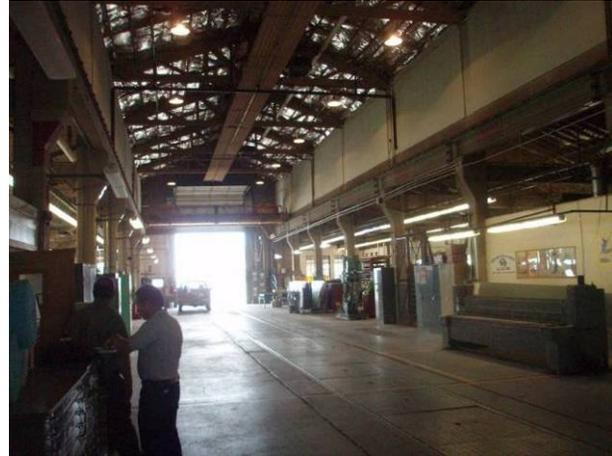
Current Overall Condition: 1 2 3 4 5 **6** 7 8 9 10 Poor-Excellent

In overall good condition.

NFPA 70, NEC dates of revisions not found. Building lighting is excellent.

Electrically this building has been upgraded with new power panels and been maintained fairly well. There are some questions about the status of the wiring but the raceway appears to be Rigid Galvanized Steel Conduit. The lighting should be looked at to be more efficient types. It appears the pad mounted transformers for the area were also replaced when the distribution went from 4160 V to 12.5 KV. The shop electrical machine tools were also functional and appeared to be in good shape.

Use as is as a maintenance shop and revise as needed for the future mission. This could easily be a part of a technical school training program. It is recommended to keep the shop in use, update the doors, and provide access and handicap restroom fixtures. A comprehensive structural engineering evaluation is needed to qualify the building for re-use.

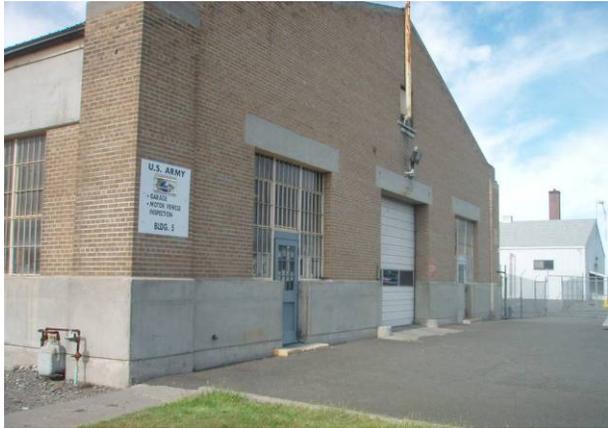
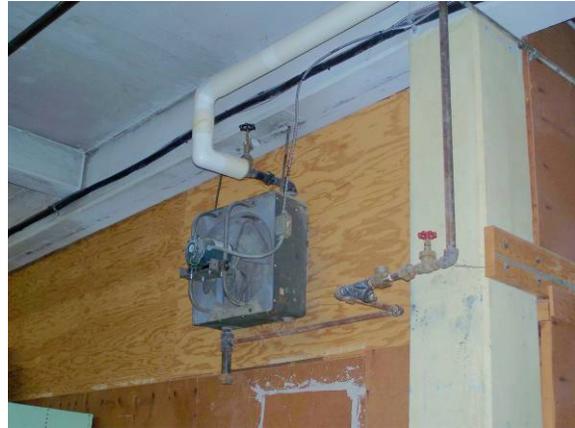
Current Overall Condition: 1 2 3 4 5 **6** 7 8 9 10 Poor-Excellent

In overall good condition. The building is a currently used vehicle maintenance shop.

Architecturally, the building is in overall in good condition. The concrete in good condition. The building could use new coating on interior vertical surfaces. Interior and exterior wash bays exist (south). Windows are single glazed windows. The exterior walls are brick masonry. The building appears to have been kept in service and maintained throughout the Depot life.

Keep in current use, update restrooms and accessibility issues. Upgrade could be made for future training usage. This building was designed and constructed as a single purpose shop. It is not a candidate for new functions and uses. A comprehensive structural engineering evaluation is needed to qualify the building for re-use

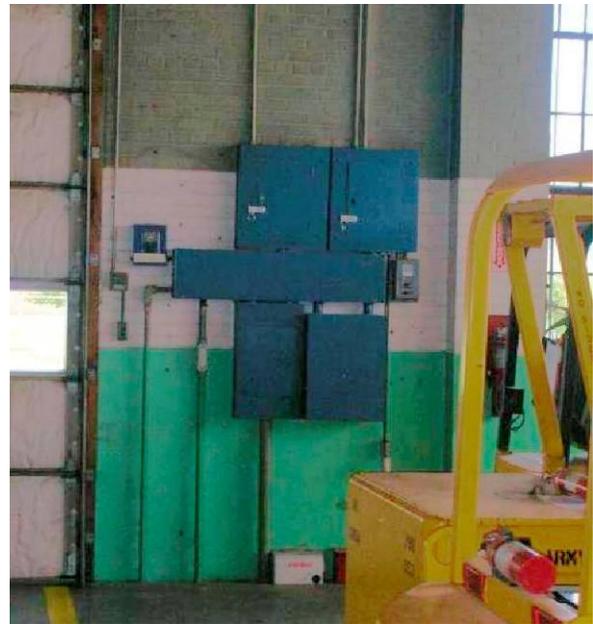
Old Main Breaker and Distribution Panel Eastside

The building is not insulated. Electrical breakers are old and would require re-test or replacement. Engine exhaust tubes extend down from the ceiling to exhaust vehicle exhaust, which should be investigated if a safety issue exists.

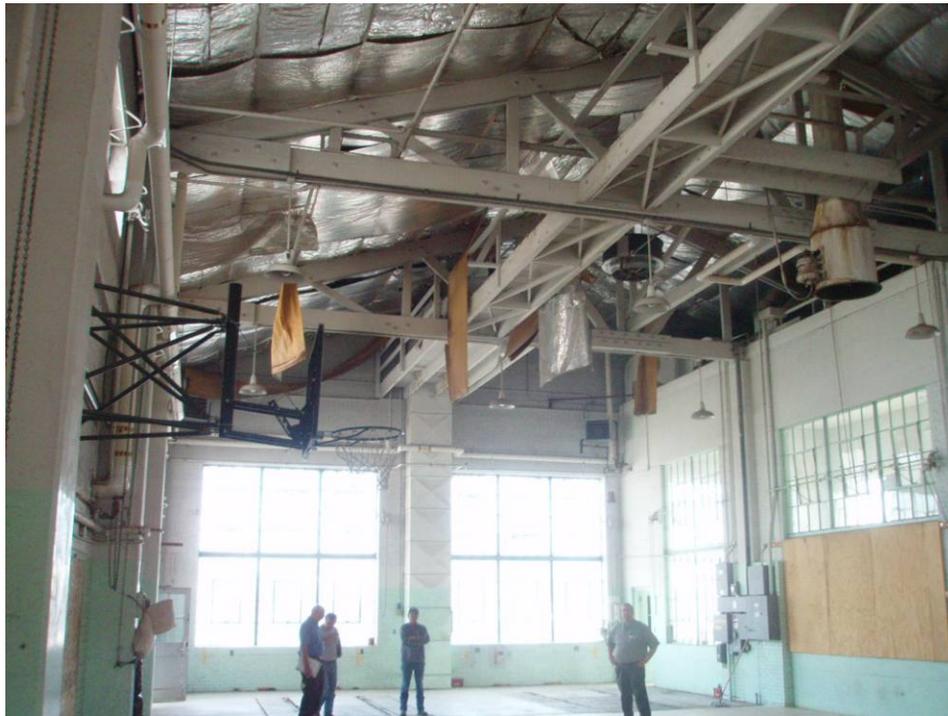
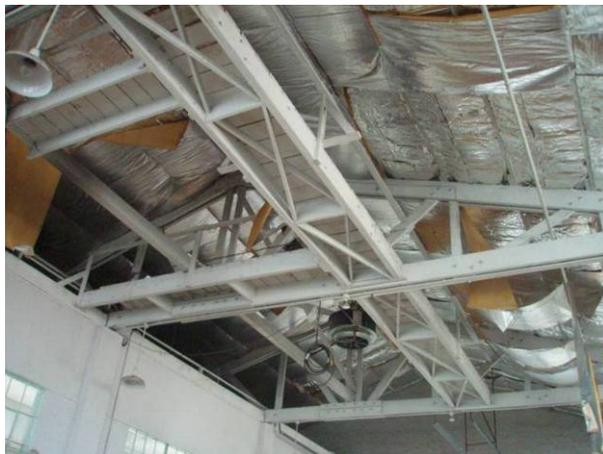
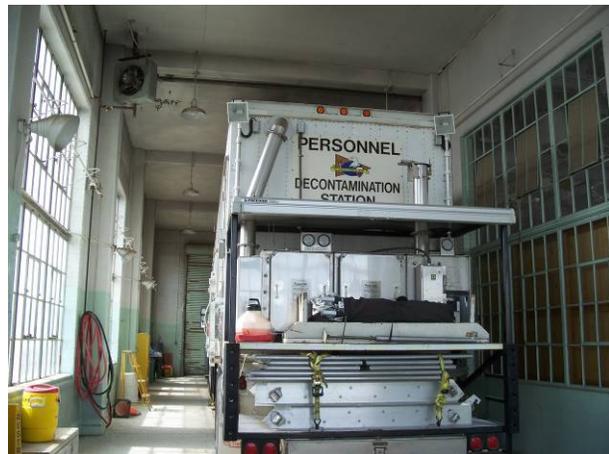
Current Overall Condition: 1 2 **3** 4 5 6 7 8 9 10 Poor-Excellent

Until needed, continue the current Decontamination vehicle storage use as long as the Depot requires.

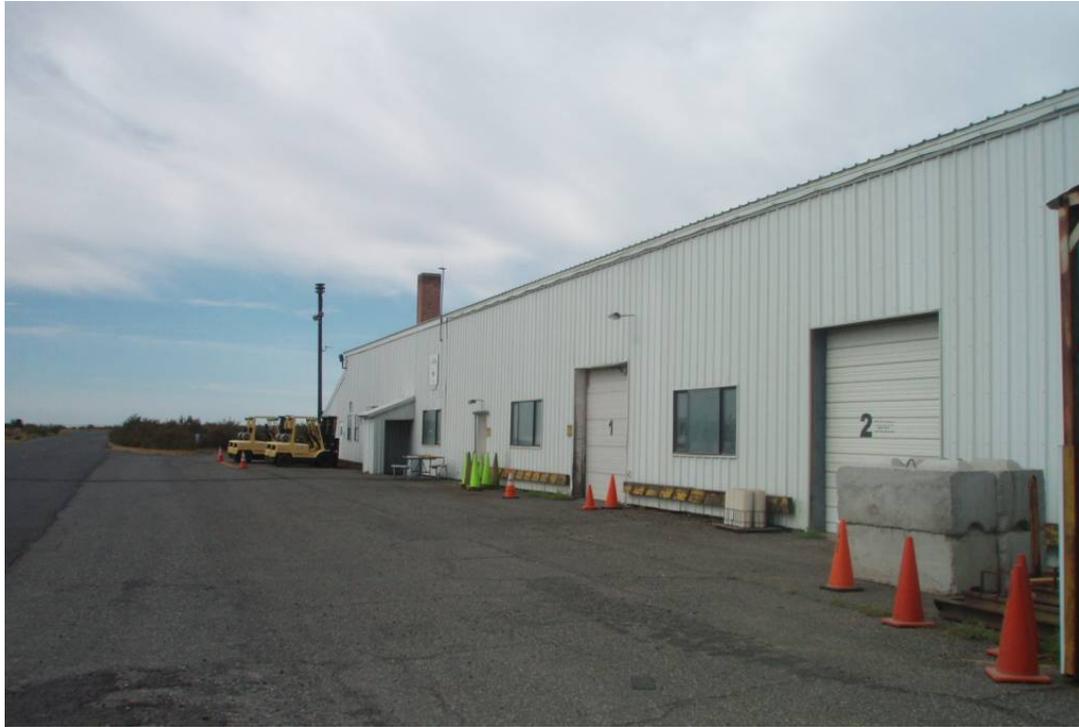
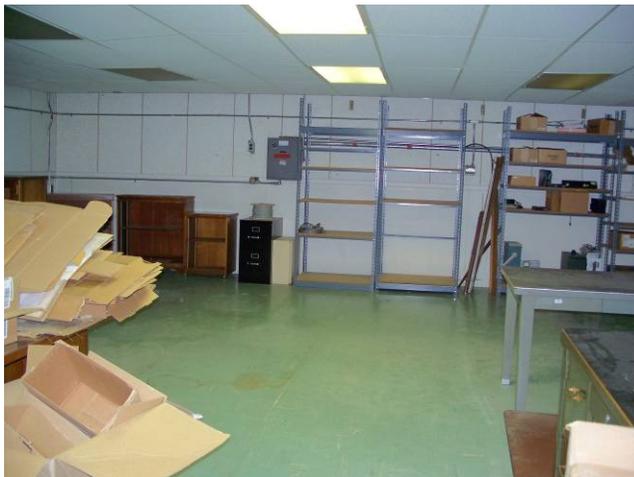
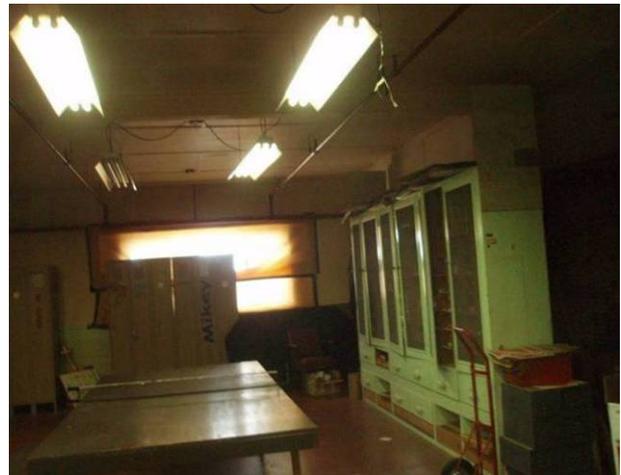
Current Overall Condition: 1 2 **3** 4 5 6 7 8 9 10 Poor-Excellent

Use for storage or tear down. It is judged not cost effective to upgrade unless a new function can be found. Recognize this building was designed and constructed as a single purpose shop or warehouse. It is not a candidate for new functions and uses.

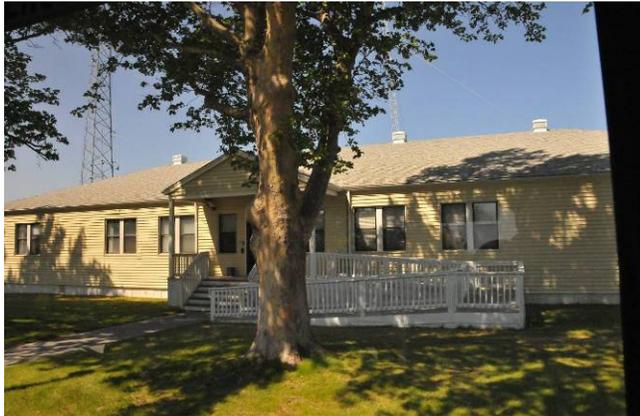
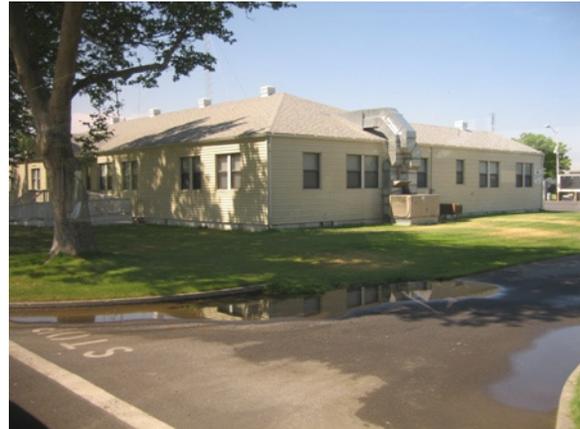
Current Overall Condition: 1 2 **3** 4 5 6 7 8 9 10 Poor-Excellent

This building might be a good visitor center for historical depot information about the area from Lewis and Clark to Oregon Trail to Army Depot days.

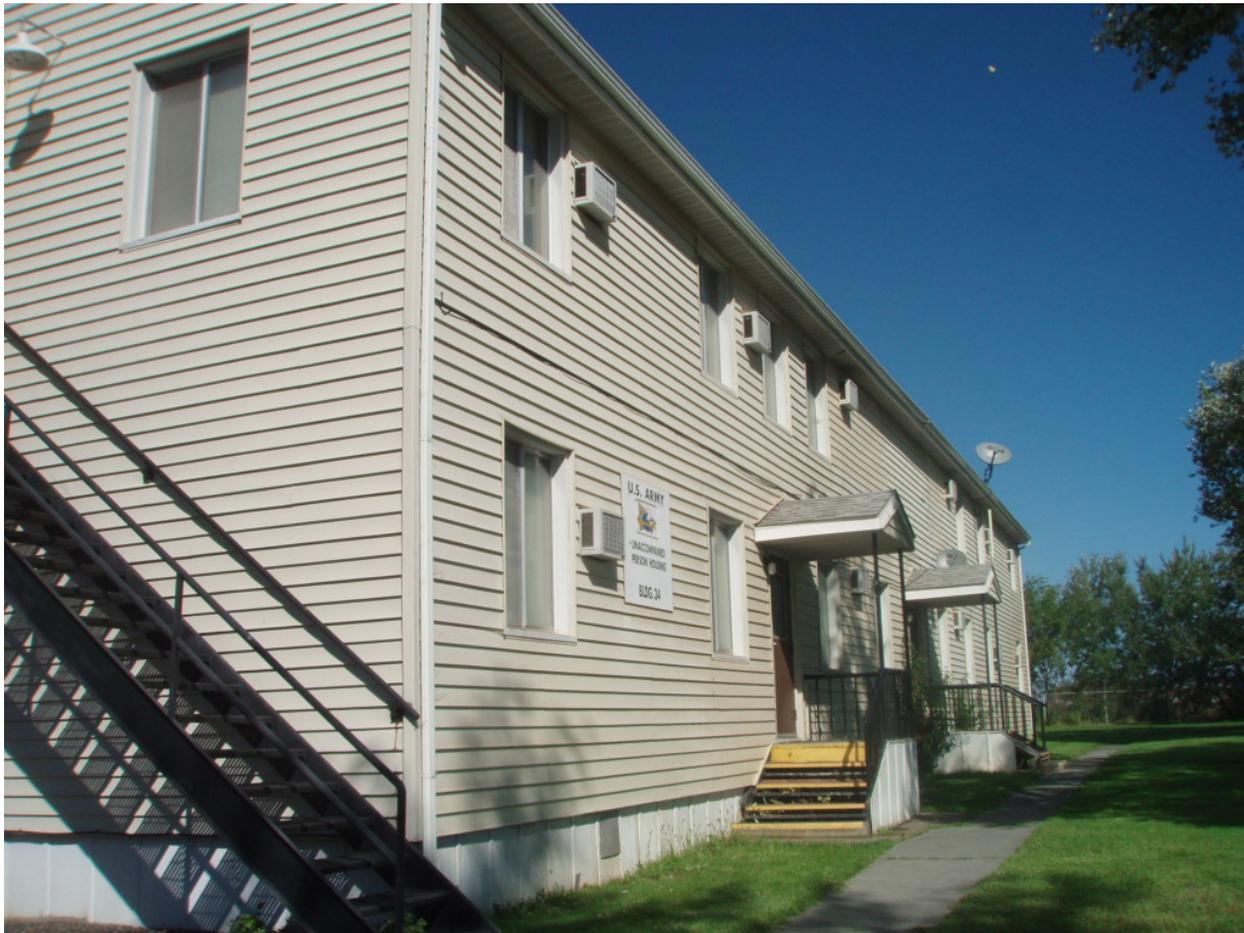
East elevation

Current Overall Condition: 1 2 3 **4** 5 6 7 8 9 10 Poor-Excellent

Access ramp to 1st floor. New south exterior stair to 2nd floor. Back exiting stairs signed unsafe. North exit stairs appear to be unsafe. Likely no draft-stops are installed. No protected stairwell

from south end of second floor. Vinyl asbestos tile (VAT) noted on second floor and (CAB) cement asbestos board noted under vinyl siding.

The interior of this building was not inspected. Cement asbestos board (CAB) was noted at exterior walls the building has replacement vinyl siding covering the CAB. Window shaker air conditioning units are installed. This exterior of this building appears to be kept in better shape than the Recreation Center

Reuse as low cost housing or tear down. A comprehensive structural evaluation is needed to qualify the structure for extended use or re-use. Bring kitchen and ventilation requirements up to code. Install fire doors where required. Some electrical upgrades and future inspection may be necessary.

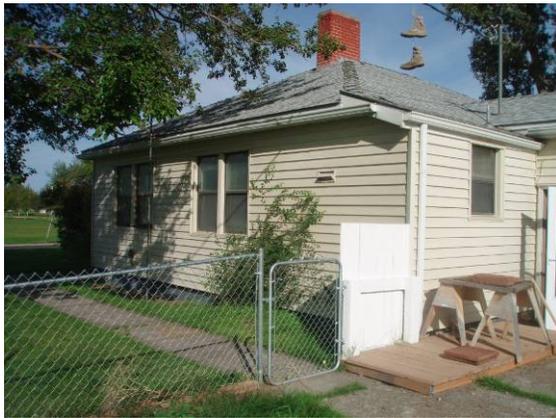
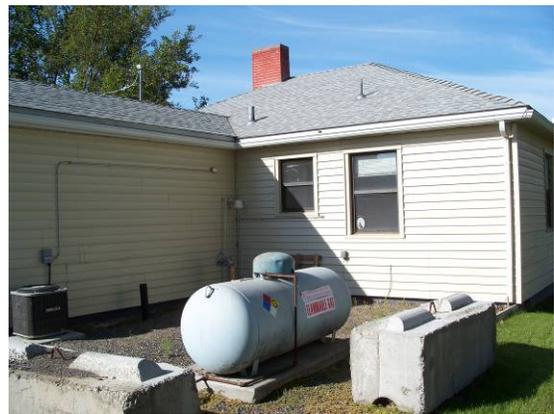
House #35- Southeast corner

Current Overall Condition: **1** 2 3 4 5 6 7 8 9 10 Poor-Excellent

The house is in very poor condition, with the interior in bad shape. The house is currently vacated. There are no landscaping and outdoor yards with fenced privacy.

Molding and interior paint are poor condition. It has replacement vinyl siding. The roof is composition shingles (new). House has double pane windows. Hard floors have vinyl tile containing asbestos. Garage may have value as a storage shed. It has hardwood floors that appear in acceptable condition. There have been recent modest low quality interior refurbishments, including repainting, and kitchen flooring. On the negative side, the property is infested, and has reached the end of its service life.

Plan and schedule demolition. Tear down and could use external services for a mobile home reconnection.

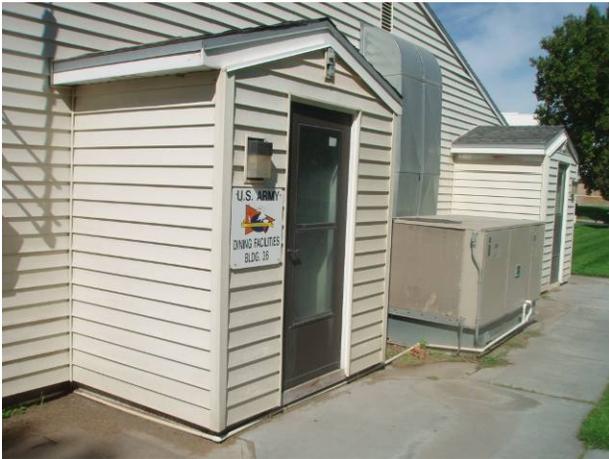
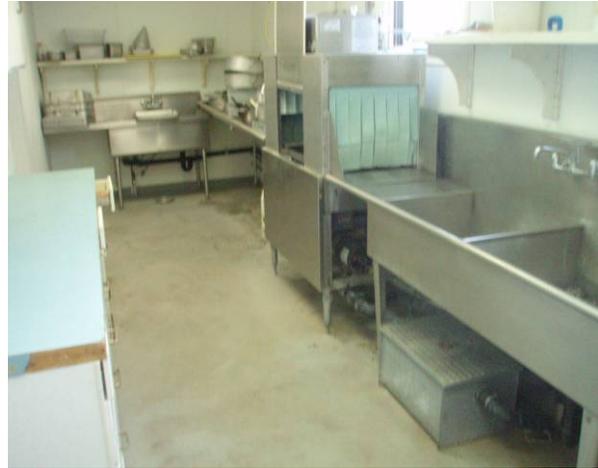
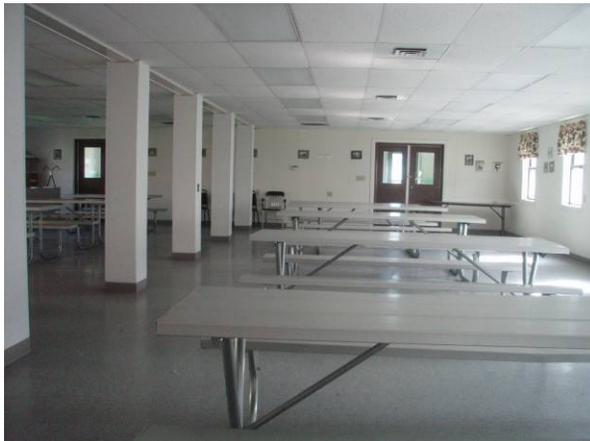
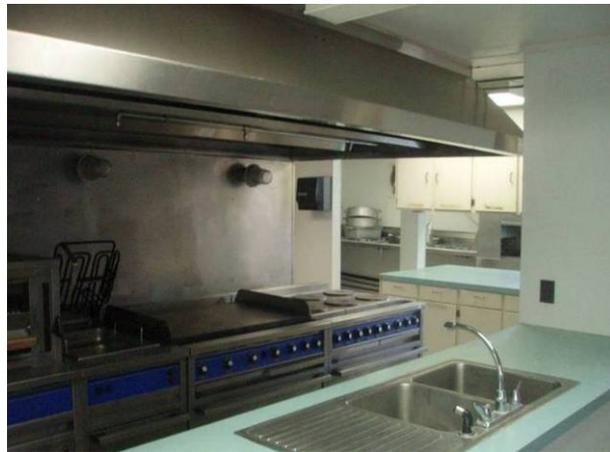
Current Overall Condition: 1 2 3 4 **5** 6 7 8 9 10 Poor-Excellent

The building appears to be in good condition. This is a group of small buildings combined into a single story dining facility. The building and kitchen were refurbished on an expedited basis in late 2001, in order to re-establish its use as a military dining hall. The dining hall is now inactive.

Wall substrate may be cab and these could be lead paint encapsulated under newer coatings. The kitchen with the exception of the Formica counters appears to be in very good shape. The walk-in freezer and refrigerator are located outside the kitchen on the south side. The dining area is nice and pleasant. The building has replacement vinyl siding with composition shingle roofing. Restrooms are upgraded and in good condition.

The building has a very nice kitchen, intact and is ready for use. Structurally, the building is recommended not to be modified.

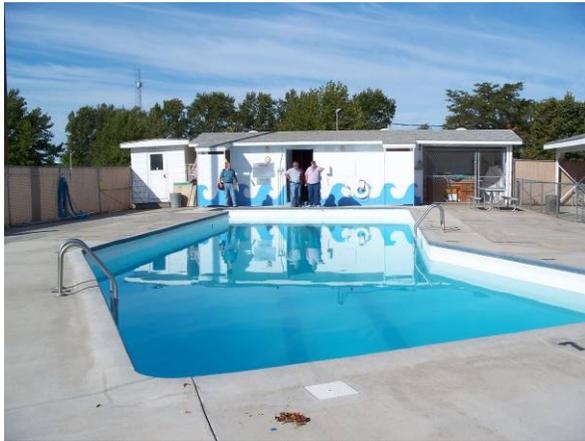
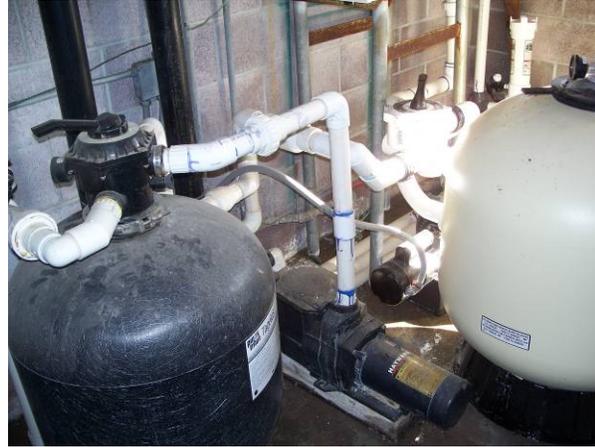
Swimming Pool

Current Overall Condition: 1 2 **3** 4 5 6 7 8 9 10 Poor-Excellent

The rooms were very tight, even for non-handicap people and the floor levels changed within the small spaces. The pool building and pool area are in generally rough condition. Beetle infestation was noted. The pool was upgraded to new drain configuration requirements. The pool and concrete deck in good condition. The hot tub is filled with sand and not used. The pool has space for poolside relaxation, including covered picnic tables and benches. The storage building is in poor condition. The restrooms and changing rooms are in poor condition, very tight with floor elevation changes, very poor restroom layouts and accommodations for swimmers. The shelter is in good condition. There is no insulation.

Replace or add to existing building to accommodate swimmers. Rewire the new building to house the new mechanical room and change rooms plus add outdoor lighting around the pool area for safety. Reinstall the main panel to comply with the electrical clearance issues. The potential for covering this pool with an air inflated cover for winter use might also be considered for year round use if that is to be considered. Also a pre-engineered metal building covering could also be considered.

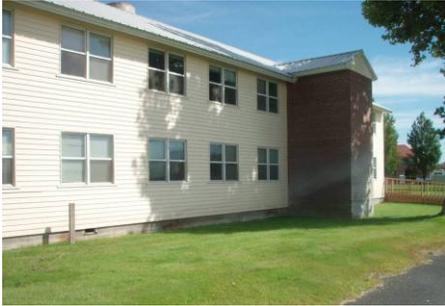
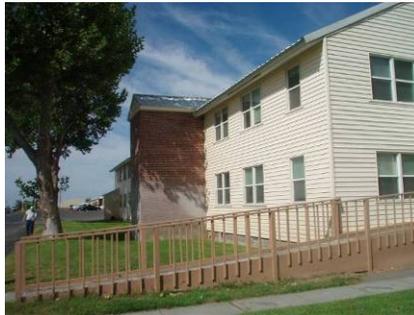
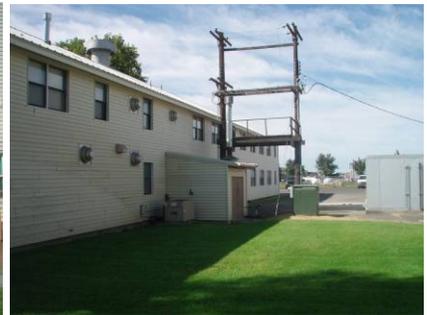
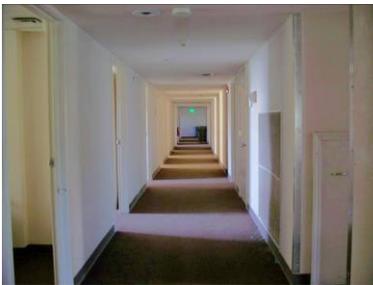
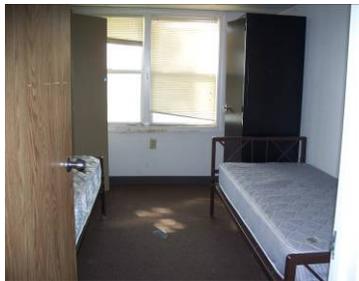
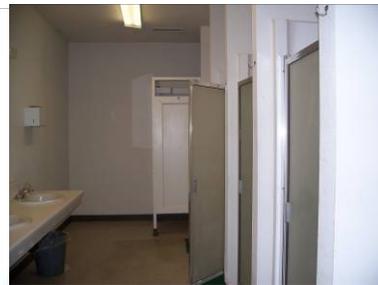
Current Overall Condition: 1 2 **3** 4 5 6 7 8 9 10 Poor-Excellent

Accessible fixtures and toilet partitions. Newer restrooms in the corridor linking the two. The remainder of the buildings has non-handicap accessible restrooms. Some rooms may have been accessible. Ceilings low on the first floor main corridor. Likely Cement Asbestos Board (CAB) and lead paint. Floors very rough, stairs need work. West stairwells may be too narrow for occupant load on the second floor. Stairwells are not protected. Exit widths are possibly not adequate. Exposed PLASTIC sprinkler piping (orange) is noted. Day room and laundry rooms are located off of the connector corridor on the east side of the building. There are no fire doors.

Surfaces rough and much worn. Would need a major upgrade for private population. Signage indicating un-sized piping to handle amount of fixture units. Windows are single glazed and walls have minimal insulation.

Code upgrades must be made before consideration for re-use. The building could be used as a school dormitory or reconfigured for low cost apartments for the homeless.

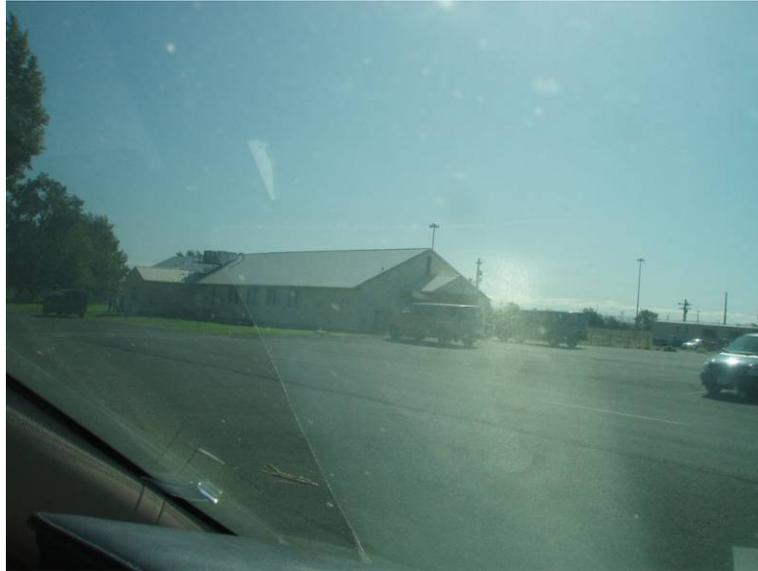
North and west elevations

Current Overall Condition: 1 2 3 **4** 5 6 7 8 9 10 Poor-Excellent

It is recommended that the building be re-used similar to current use, or revised as needed to fit a new application.

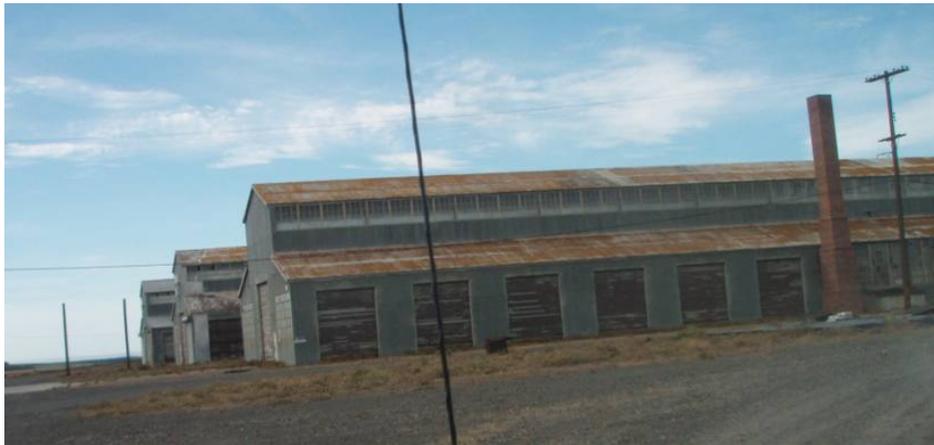
Deteriorating Building

The structural condition of the metal warehouses is questionable because the extent of oxidation is not known. If these facilities were stripped of their outer shells and decontaminated the remaining skeleton structure could be reused provided that a thorough structural analysis and inspection was conducted.

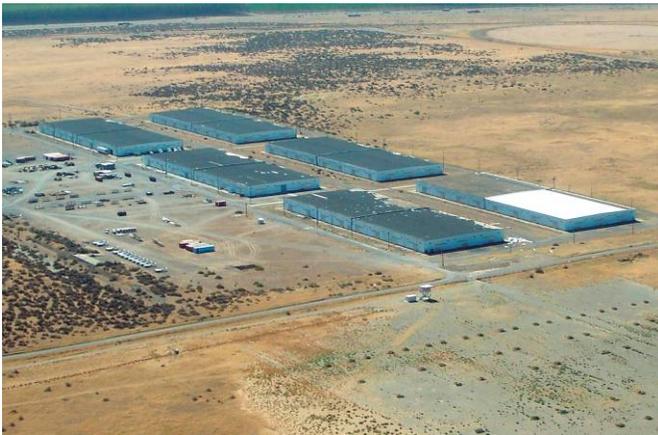
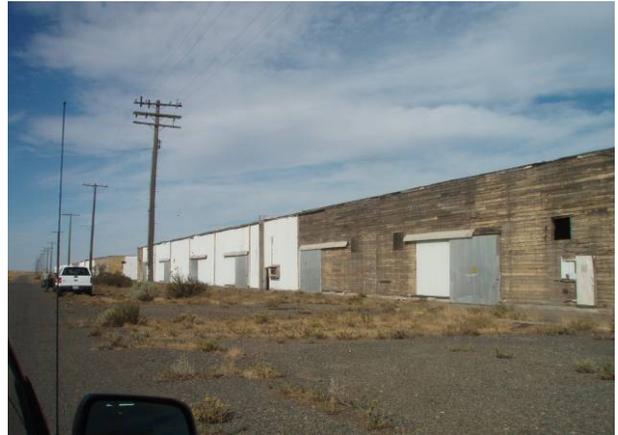
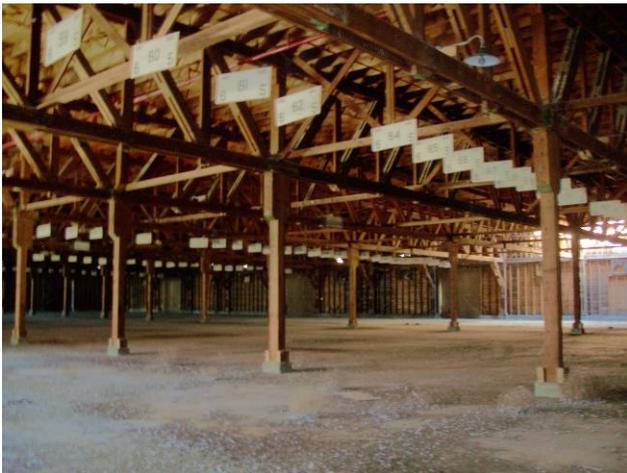
200 Series Warehouses

Typical interior without upgrades

If not reused it is recommended that these structures be torn down and removed. If that alternative was selected, the buildings' concrete foundations and loading docks could still be used for other purposes such as outdoor container storage. Upgrade power poles and lines for multiple warehouses operating at the same time, and replace any poles damaged by fire. Add security lighting to the 200 Series warehouse area.

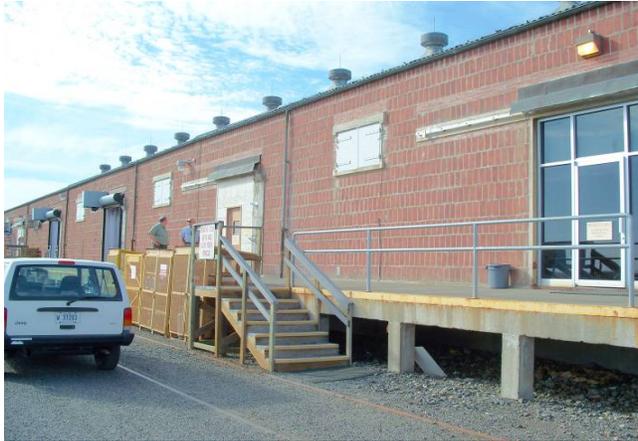
400 Series Buildings- Un-refurbished

Continue the current warehouse, receiving and storage (low occupancy). Recognize that in the event of earthquake, due to the type of fragile brick construction of the 400 series building walls, ground motions could threaten the occupants and passersby. A comprehensive structural evaluation is needed to qualify the structure for re-use.

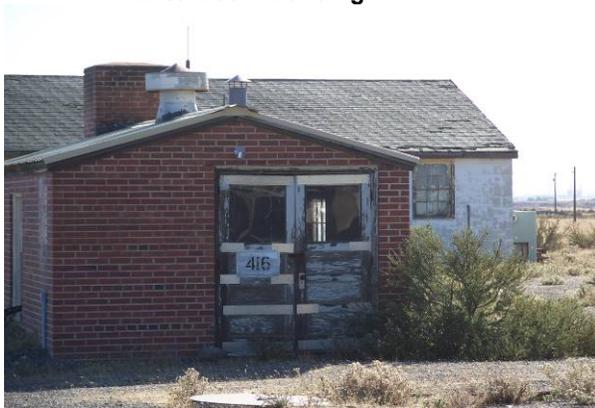
Breakroom Building

Buildings are in extremely poor condition. Numerous violations of codes and standards are prevalent throughout. The Surveillance Workshop and old Breakroom building are not accessible.

Buildings are very rough and not useable. Surveillance building could be used with extensive upgrading, but the Boiler Bldg and the Break room are structurally and environmentally hazardous. Leaky roofing and failing siding and windows has led to intrusion of the elements and pigeons resulting in widespread deterioration. Electrical systems are very poor condition and not feasible to re-energize.

These buildings should be completely torn down and removed.

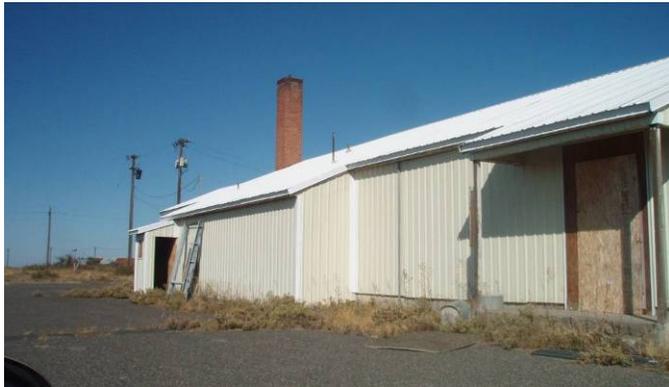
Ammunition Operations Breakroom Building – South

Building 419 is in extremely poor condition. It is expected that numerous violations of codes and standards are prevalent throughout. Building 419 was not accessible and is not in use.

Building 419 is very rough and not useable. According to the Army representative, the building has new siding but is otherwise in very bad condition inside. It was used as breakroom and laundry. The building had a wash-down area, chemical cleanup before K-Block and old showers. The building likely possesses a mix of hazardous chemicals, lead paint and asbestos. It was used up to 9/11 and then used for siege practice, and contains lots of paintball paint on the walls.

The Ammunition Operations Breakroom Building Building 419 should be torn down and not reused.

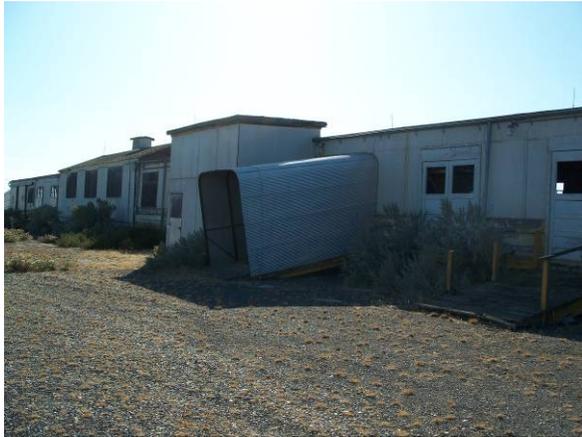
Ammo Operations Building
(West bldg- North side)

Other/Notes: The “Ammo Operations Building”, “Boiler Building” and “Less than a truckload” Building” are all in very poor condition.

Buildings are in very poor condition and codes and standards cannot even be considered. Electrical is not in service. Structurally and environmentally, the buildings are hazardous.

Buildings are very rough and not useable. Metal, Concrete wood trusses and asbestos has been noted.

Buildings 431, 434 and 433 (“Ammo Operations Building”, “Boiler Building” and “Less than a truckload” Building”) should be torn down.

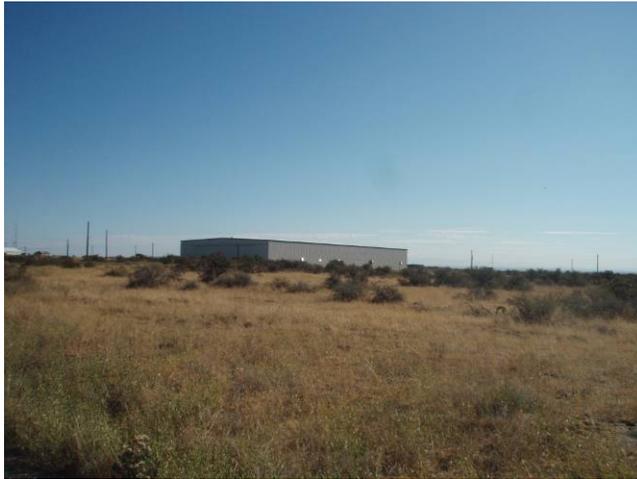
Bldg #450 West elevation

This building is used for RV storage only. The current structure is a pre-engineered metal building. No heating is available in the building and no insulation is in the ceiling or the walls. The sky lights in the roof give good lighting for RV Storage. The building has not exit lights or egress light and can only be accessed in night time with a flashlight. The only receptacles found are located next to the power panel on the Northwest corner. There is also a 1 ½" fire pipe connection and a hose connection which did not appear to be charged with water. There is a potential for RV spills on the floor spaces. There is also a fire potential from stored vehicles. There are extensive outdoor parking spaces. The roads are in very poor condition but passable.

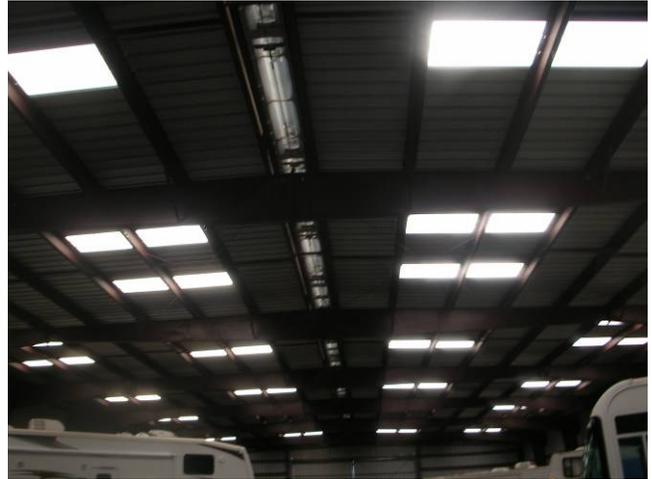
Bldg #450 (Skylighting only; automatic roof vents)
